Subject: Motorcoach Safety Research

NIST Technical Note 1653

**Motorcoach Flammability Project
Interim Report: Tire Fire Penetration
into the Passenger Compartment**

April 2010

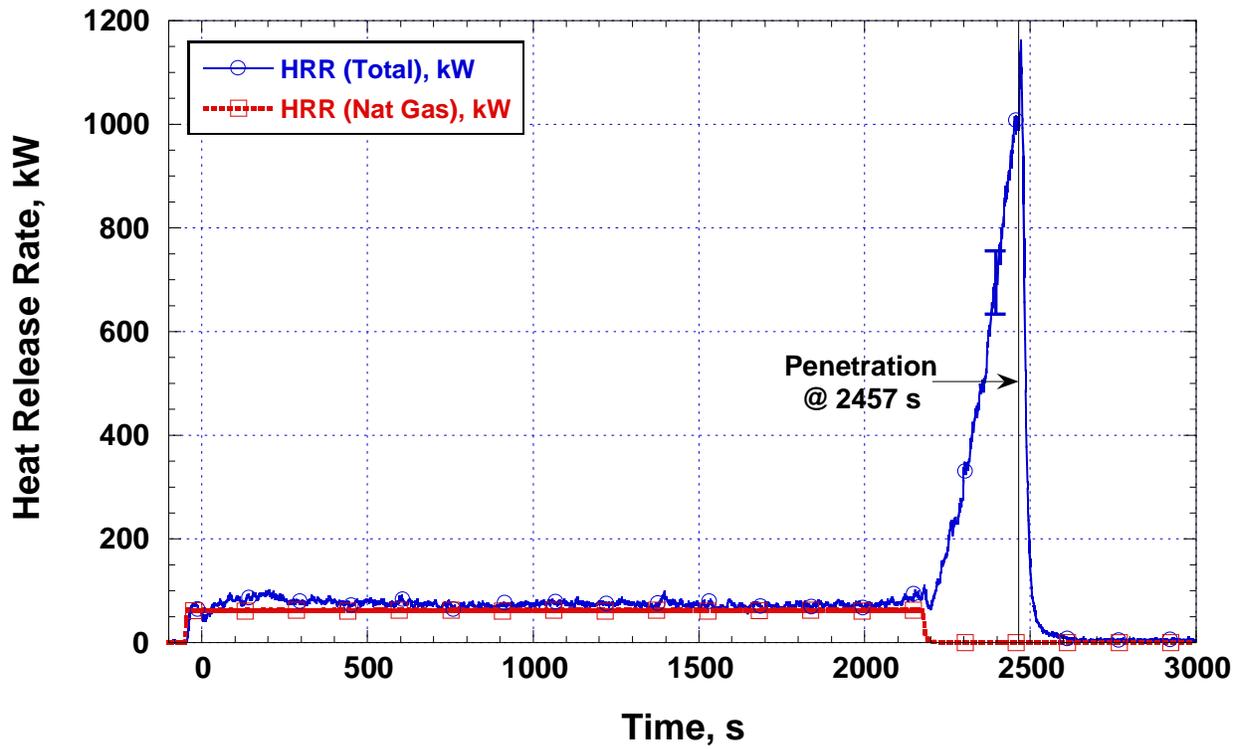
For the first test, the total heat released by the burner and motorcoach materials was 323 MJ, which consisted of 138 MJ (43 %) from the burner and 185 MJ (57 %) from the bus materials. For the second test, the total heat released by the burner and motorcoach materials was 341 MJ, which consisted of 77 MJ (32 %) from the burner and 264 MJ (77 %) from the bus materials. The total heat released during each test was similar, but the drive axle test required much less heating (56 %) for the reasons described in the previous section on event timing. During the drive axle test (#2), 43 % more bus material was burned than in the tag axle test (#1). The drive axle tire fire actually spread to the tag axle tire causing two plumes to merge and involving more of the exterior panel than the single plume from the tag axle test. Also, the tires and exterior panels burned longer before penetration during the drive axle test.

Figure 17 Heat release rate plotted versus time for test 1, the heated tag axle wheel experiment.

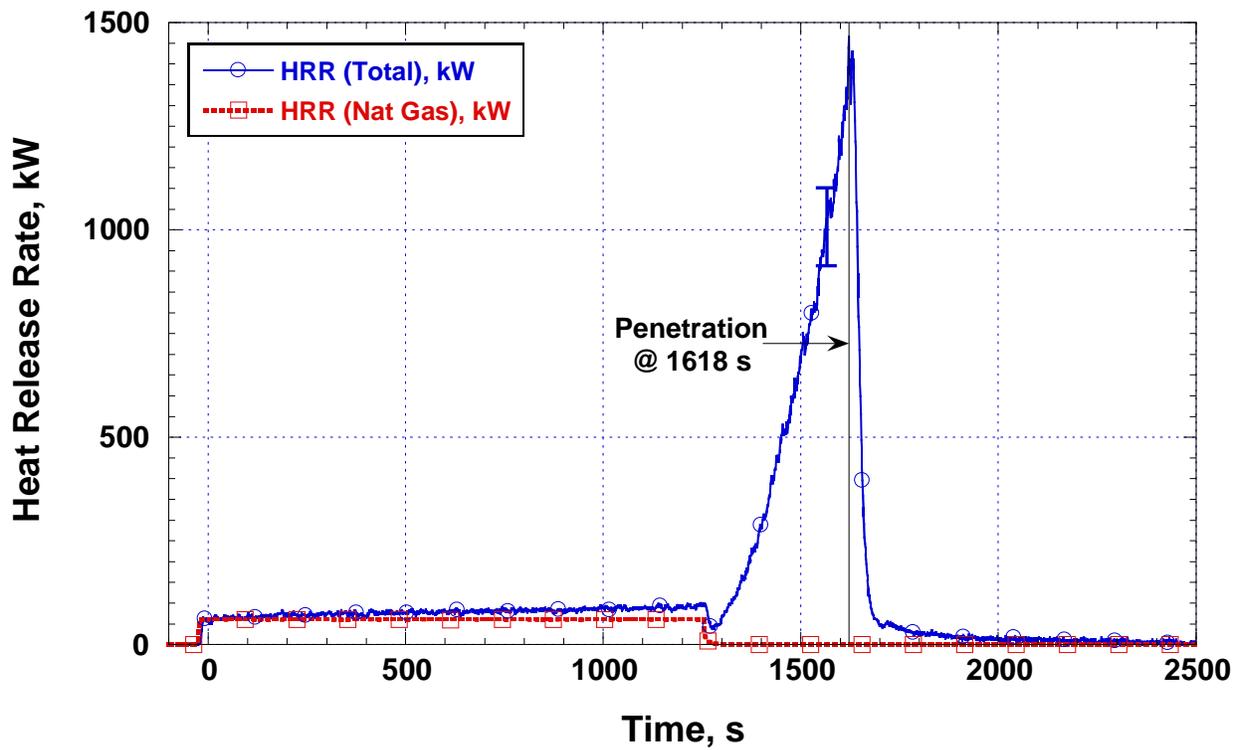
Figure 18 Heat release rate plotted versus time for test 2, the heated drive axle wheel experiment.

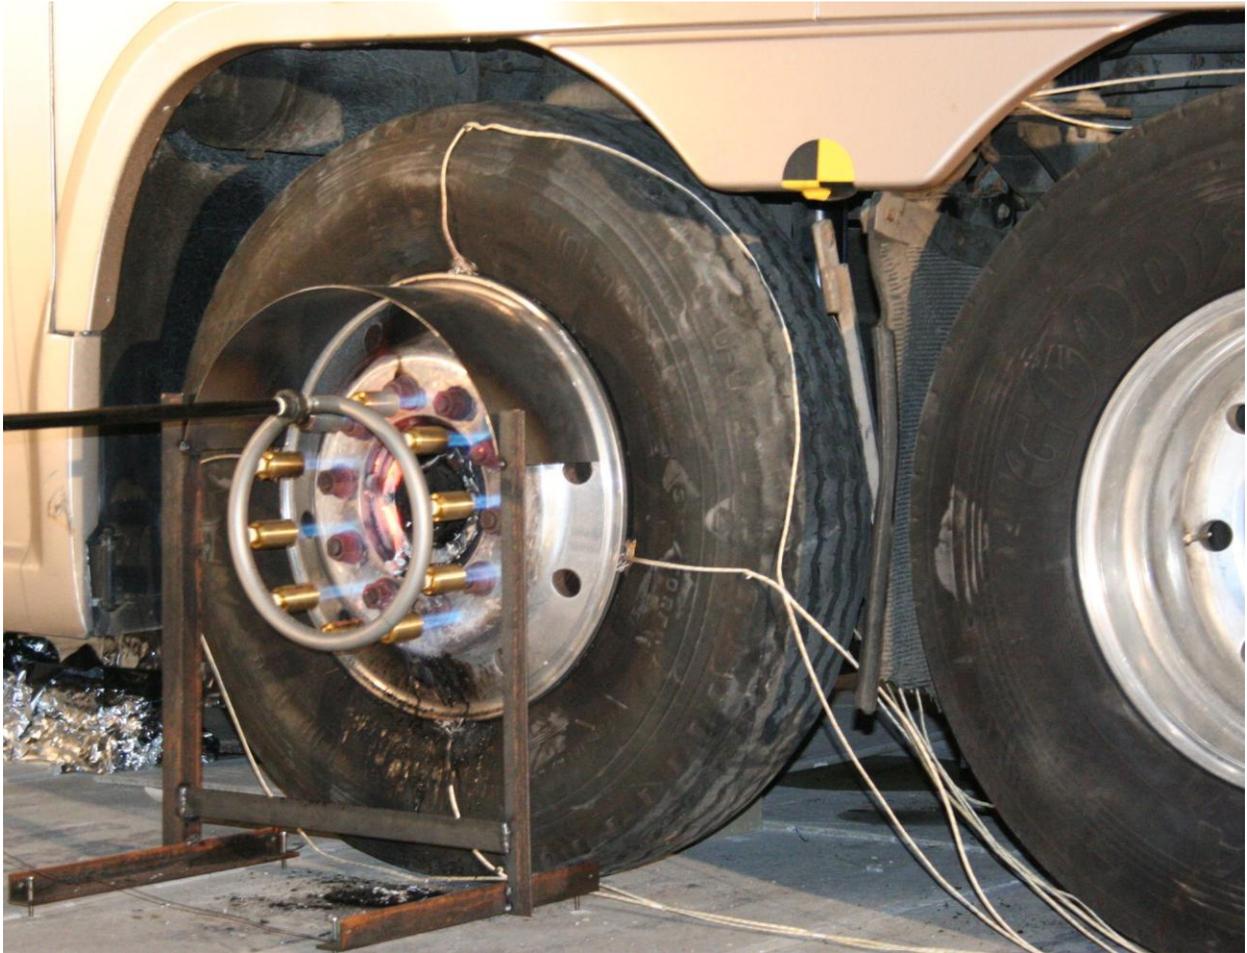
Figure 41 Tag axle wheel heating experiment showing burner, shield, melted hub, and early thermal damage to tire.

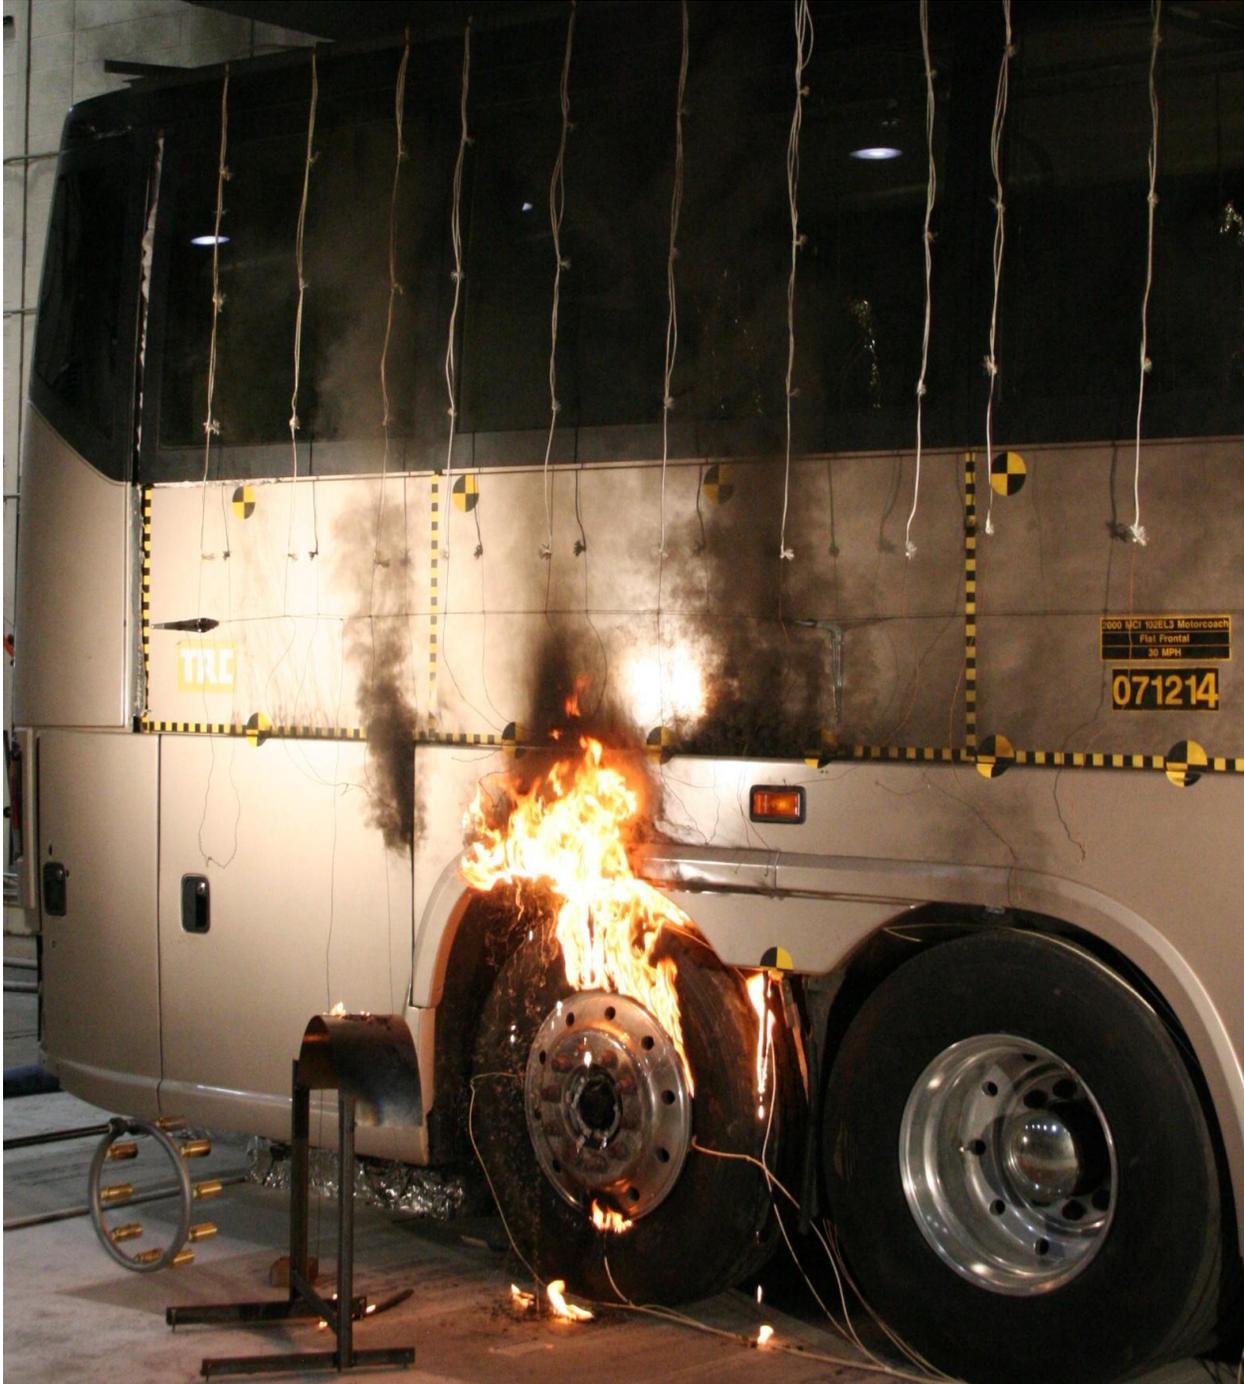
Figure 42 Tag axle wheel heating experiment about 1 min after the burner was removed. The fender is already burning and the exterior panel is just igniting.

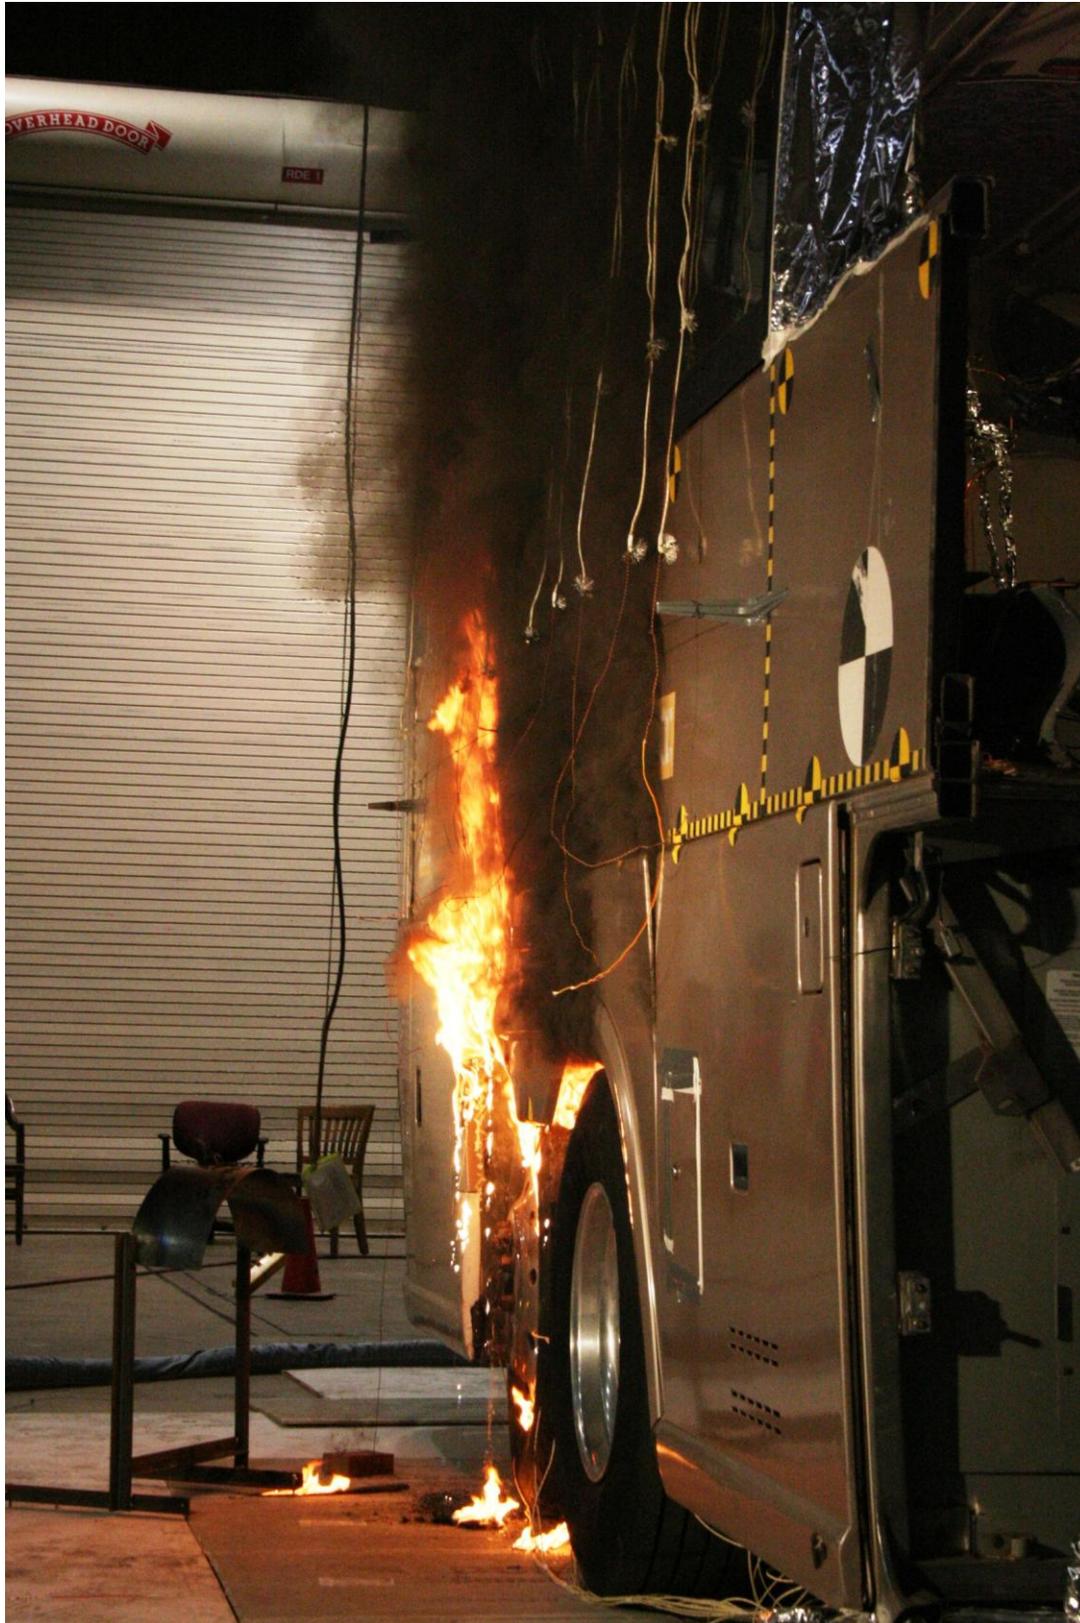
Figure 43 Tag axle wheel heating experiment about 2 min after the burner was removed. The exterior panel is burning up to the windows.

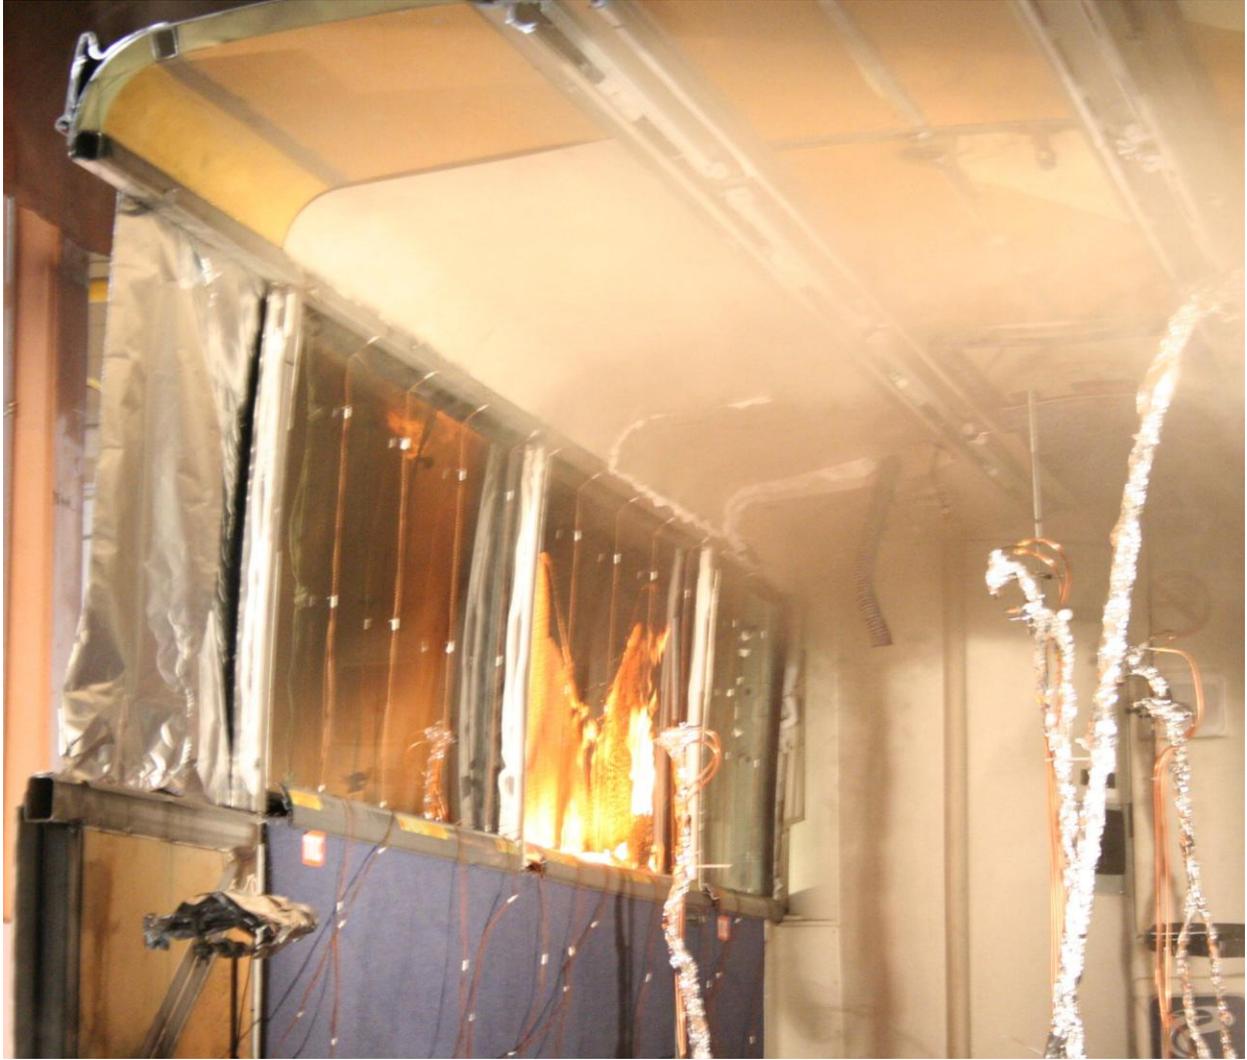
While breaking the windows was the path by which the fire penetrated into the passenger compartment, the windows did not break easily. The window design was two glass layers with a clear laminate layer between them. The inner glass was a safety type which shattered, and the outer was not. It is noteworthy that the glazing layers often broke independently from each other with the fire impinging on the outside. For the drive axle experiment, glass layers would sometimes fall in or out, but it took about 2 min from cracking of glass to the time that layers started falling away and another minute for any areas to have both layers break off, creating a hole and path for fire entry. Some of the pieces of glass with burning laminate fell inside and burned on the floor, but this was not considered fire penetration although it is possible that the burning material could have ignited seat cushions if they had been installed. Also, material between the front most window and post 3 was burning during the second test but was not considered fire penetration.

Figure 46 Tag axle wheel heating experiment at fire penetration.

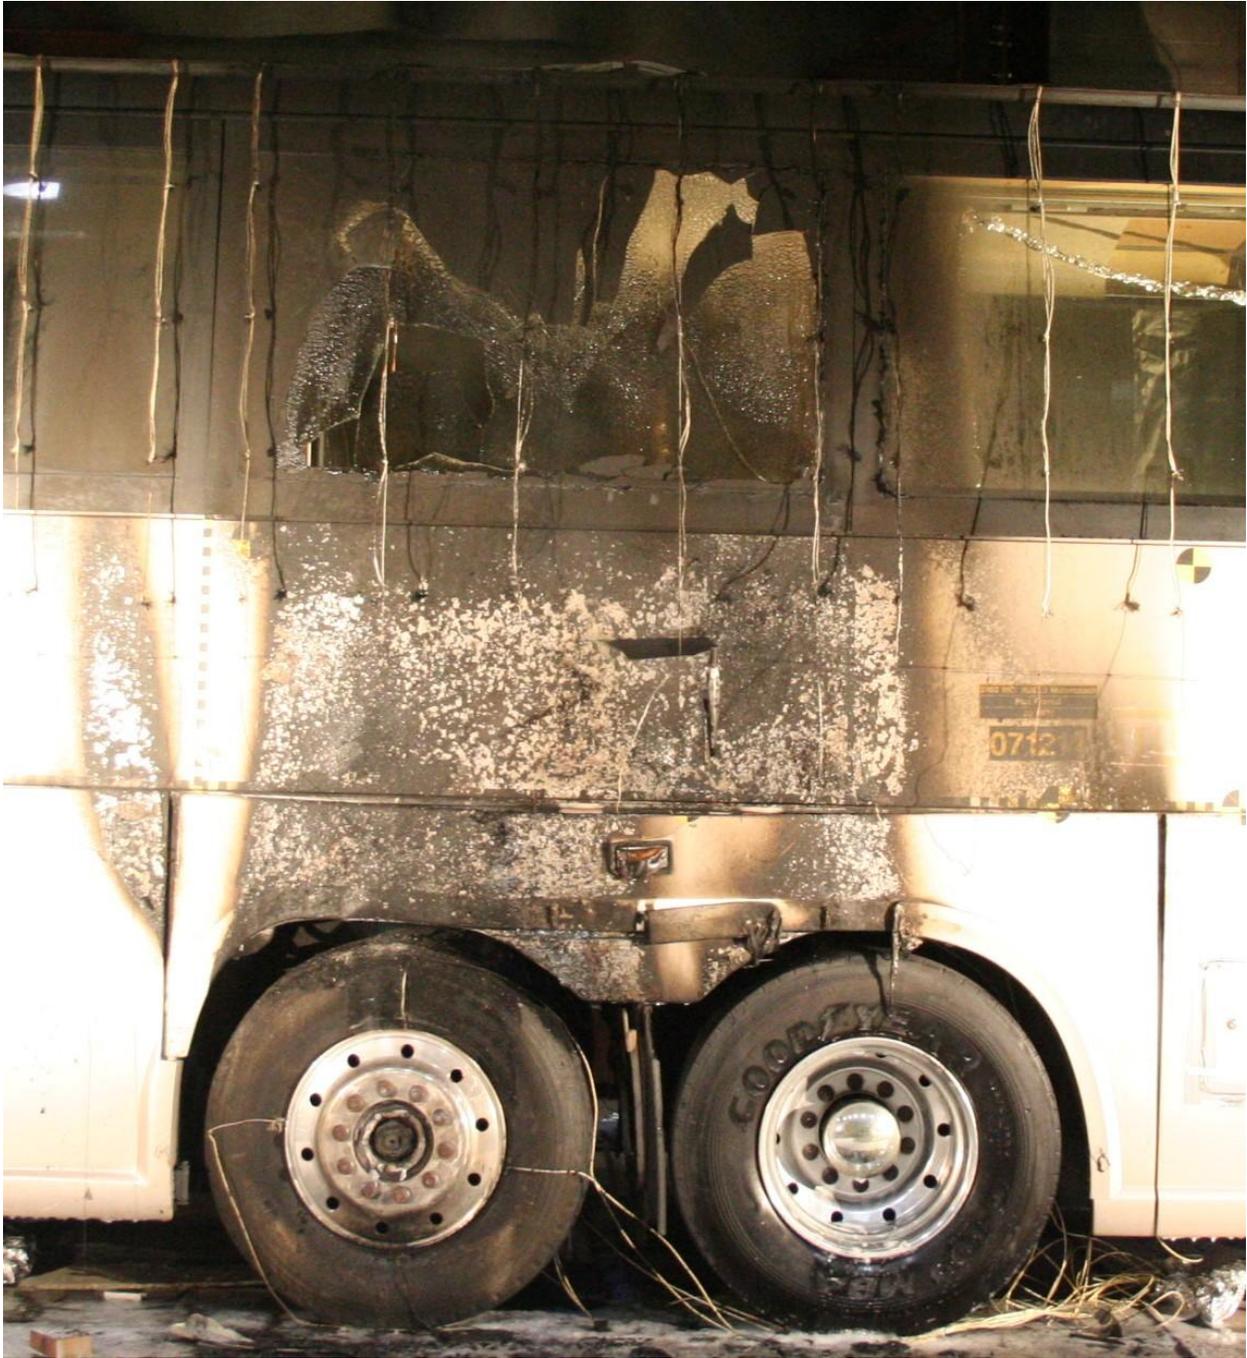
Figure 47 Exterior fire damage due to tag axle wheel heating experiment

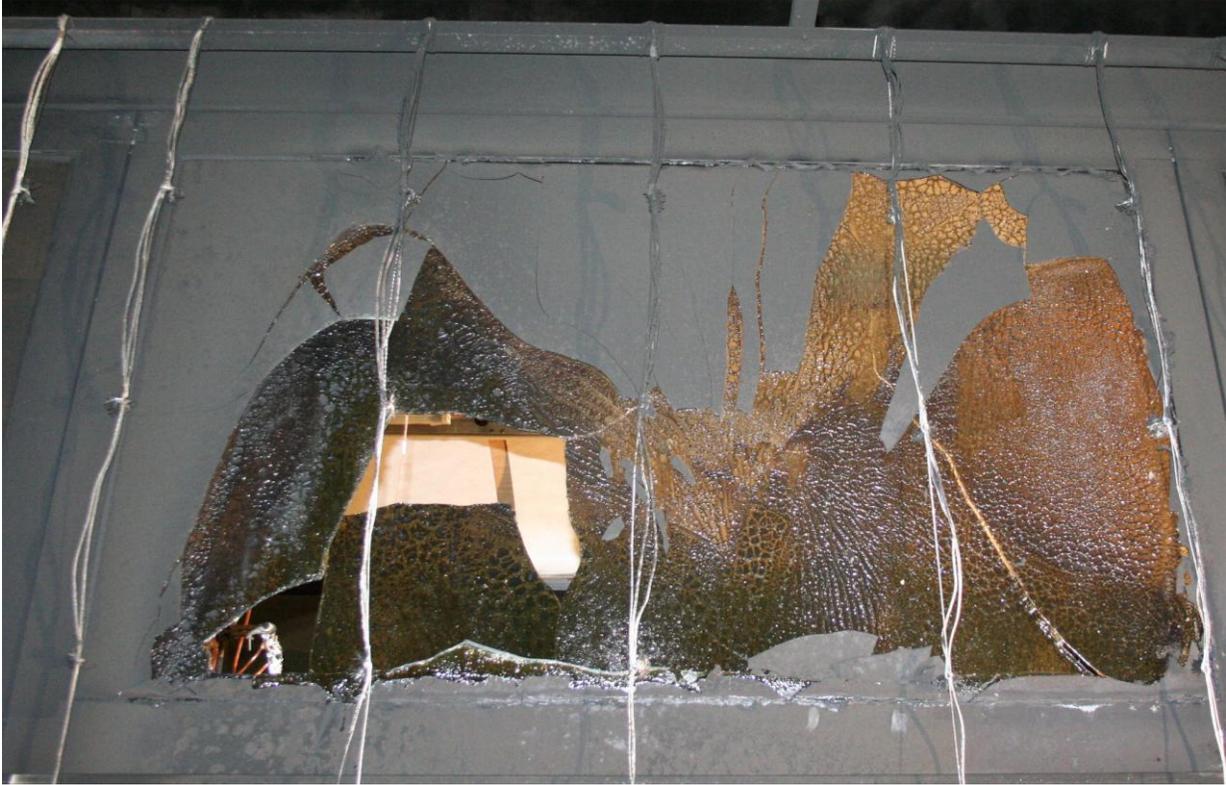
Figure 48 Exterior view of window damage after tag axle wheel heating experiment.

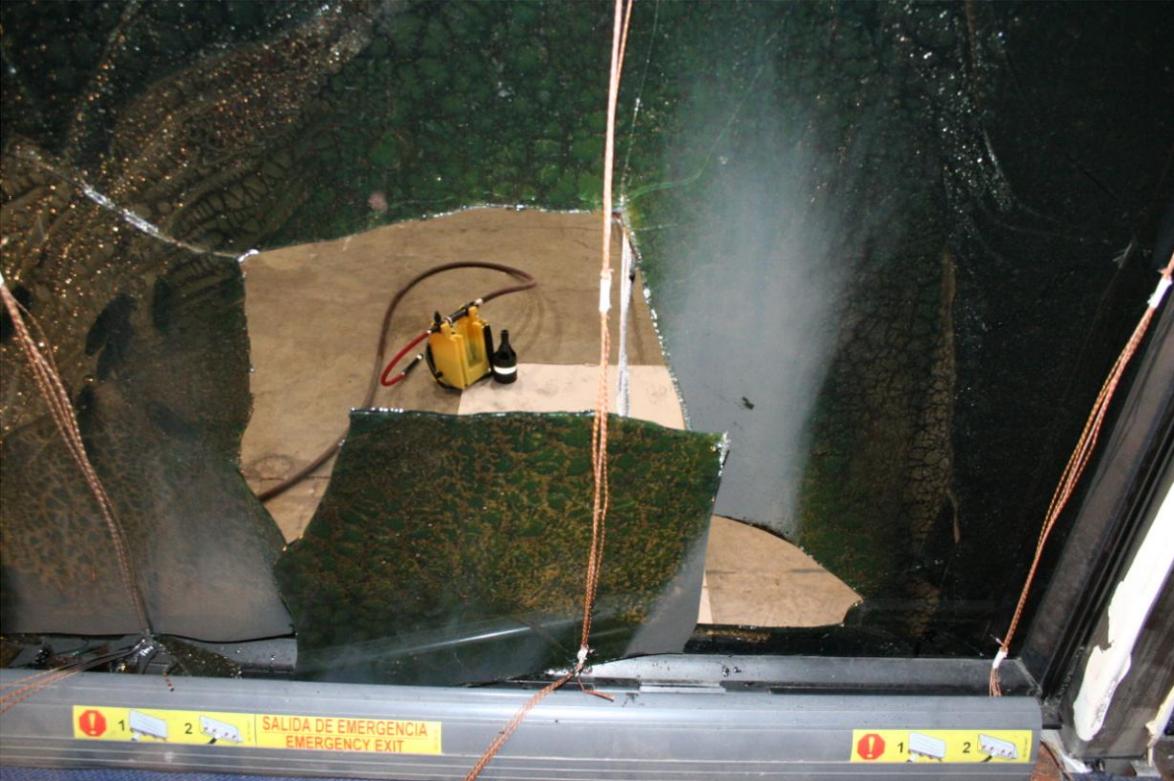
Figure 49 Interior view of window damage after tag axle wheel heating experiment.

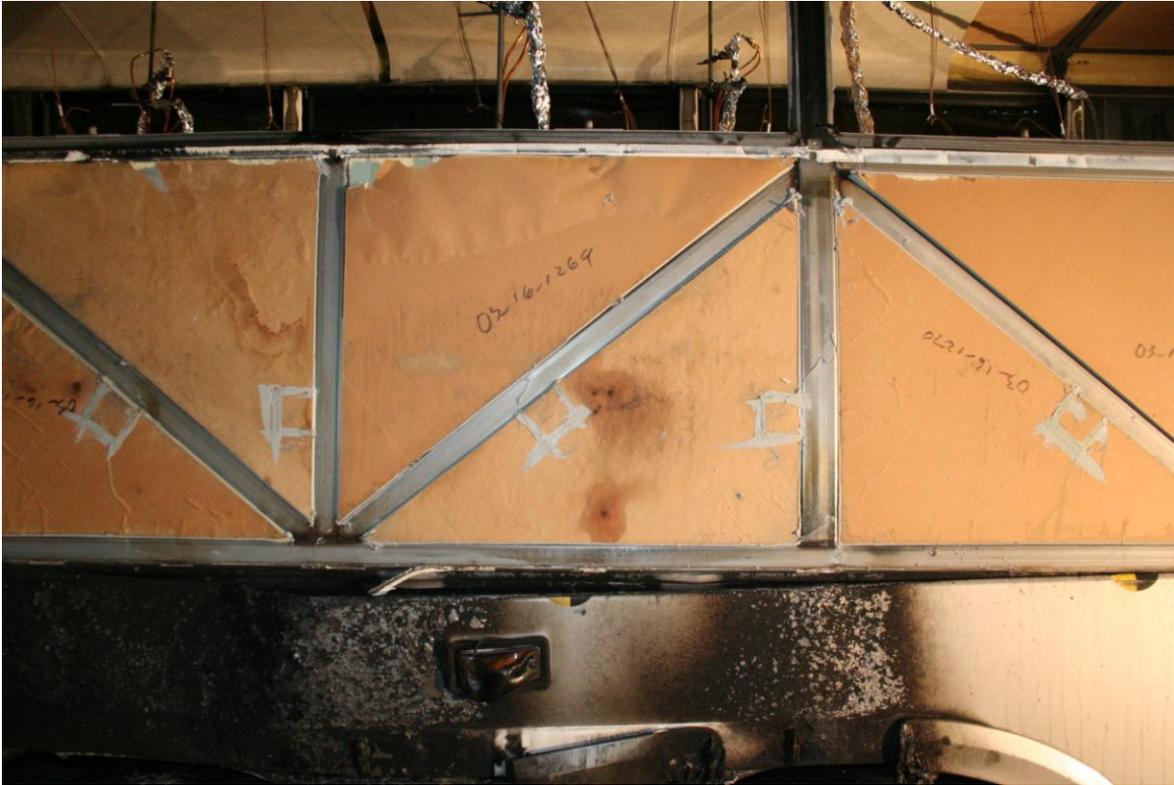
Figure 50 Damage to wall behind exterior panel after tag axle wheel heating experiment.

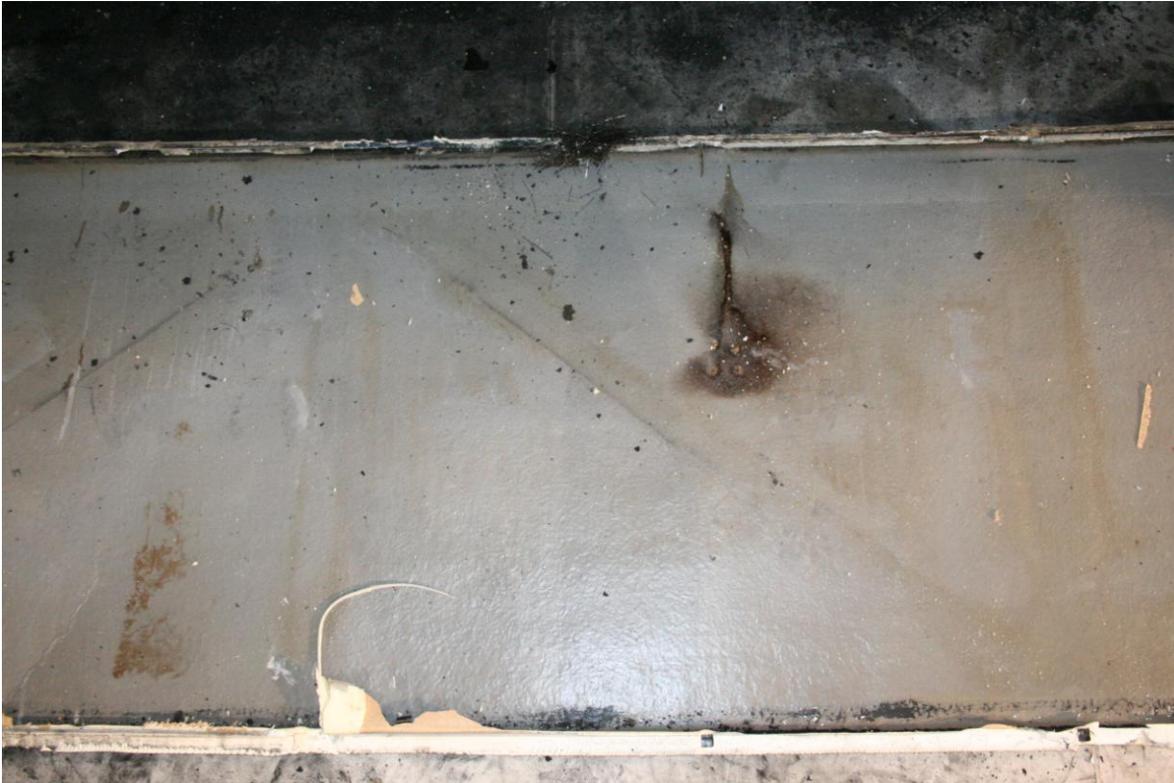
Figure 51 Damage to back side of exterior panel showing little penetration of fire through the GRP.

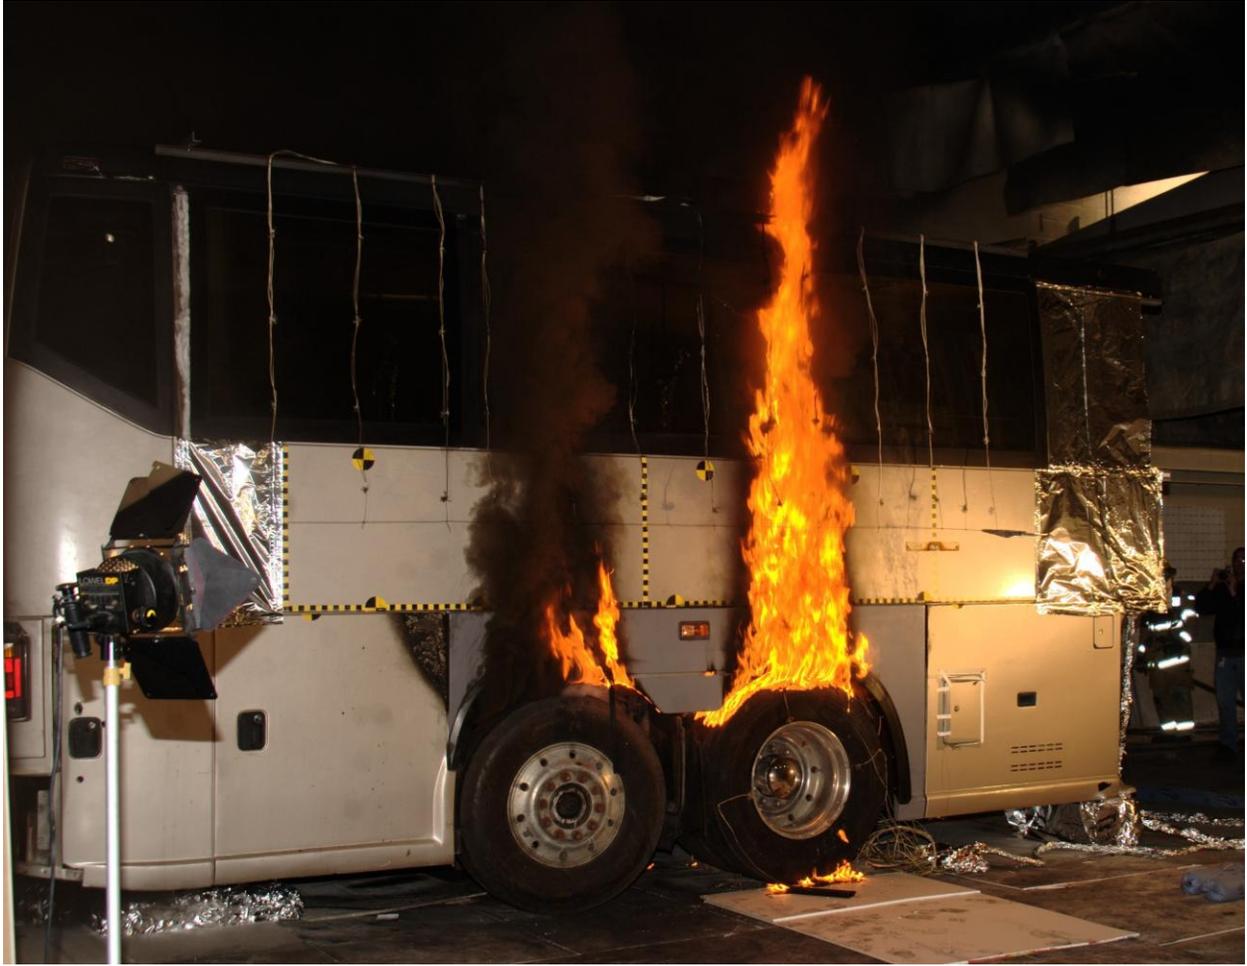
Figure 60 Drive axle wheel heating experiment showing fire spreading from the drive axle to the tag axle area of the fender.

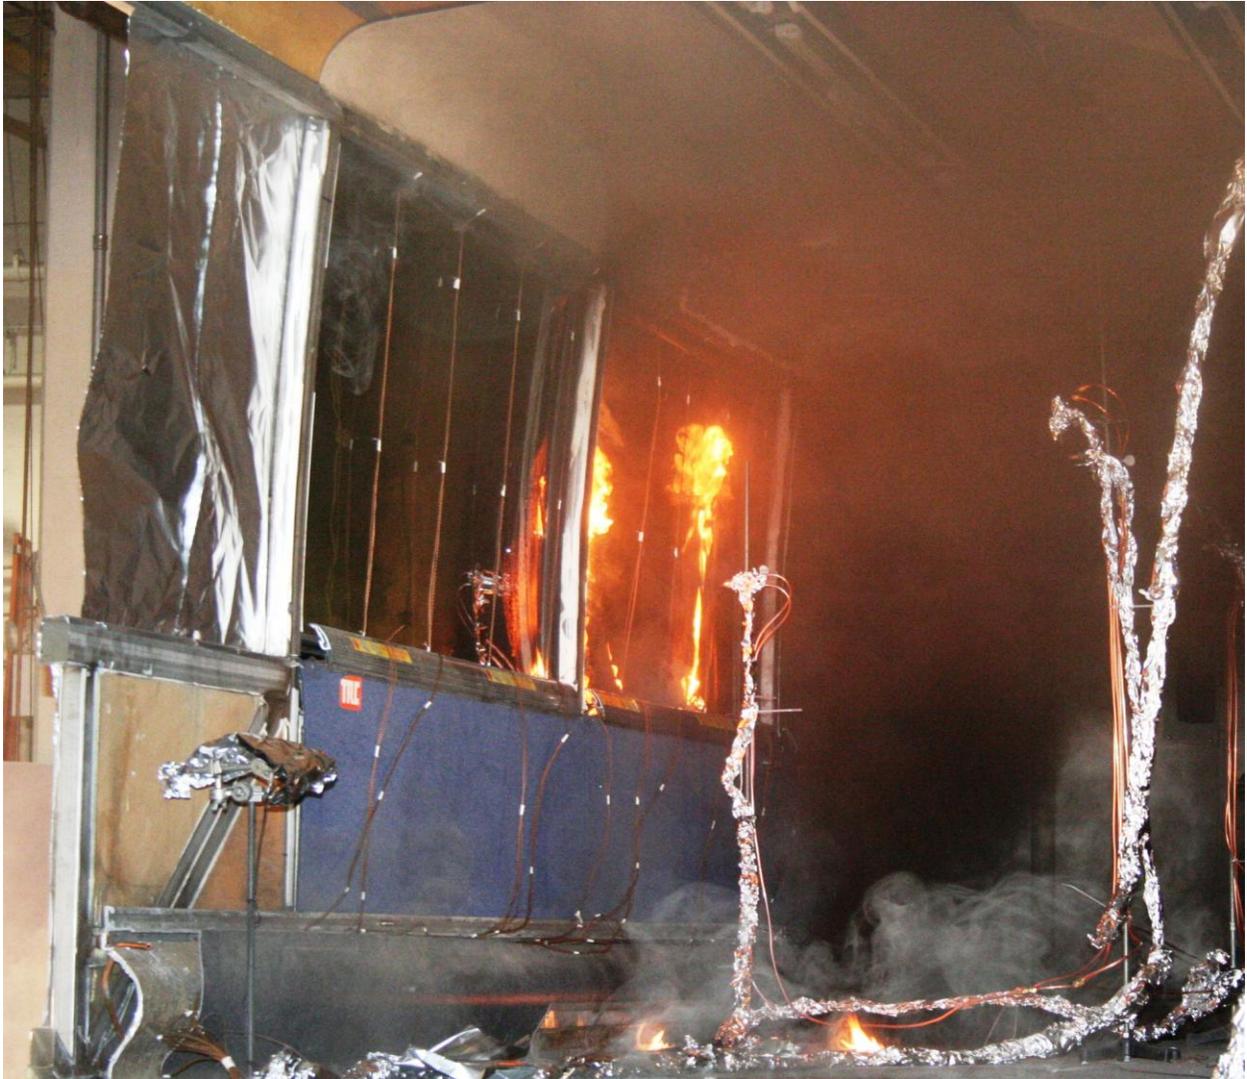
Figure 67 Drive axle wheel heating experiment at fire penetration. Window breakage occurred on the more rearward window while the burning tire was fairly centered on post 3 between windows.

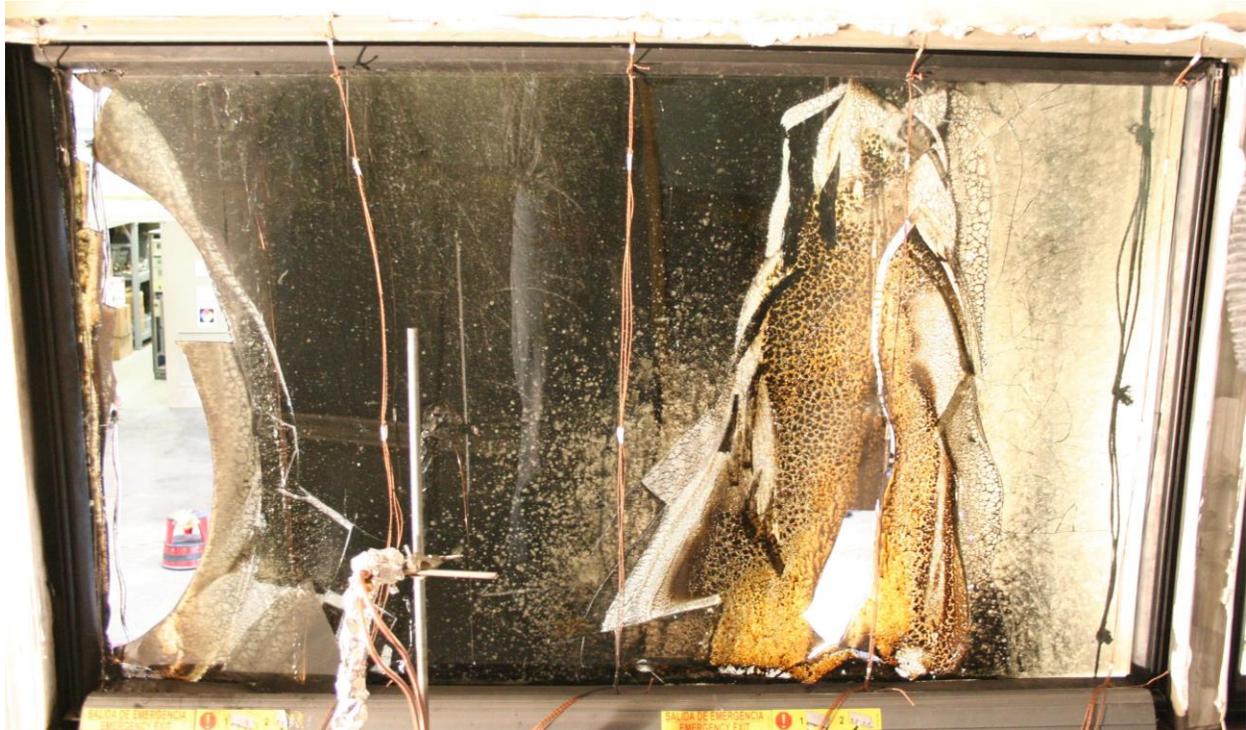
Figure 69 Interior view of damage to the window over the tag axle after the drive axle wheel heating experiment fire.

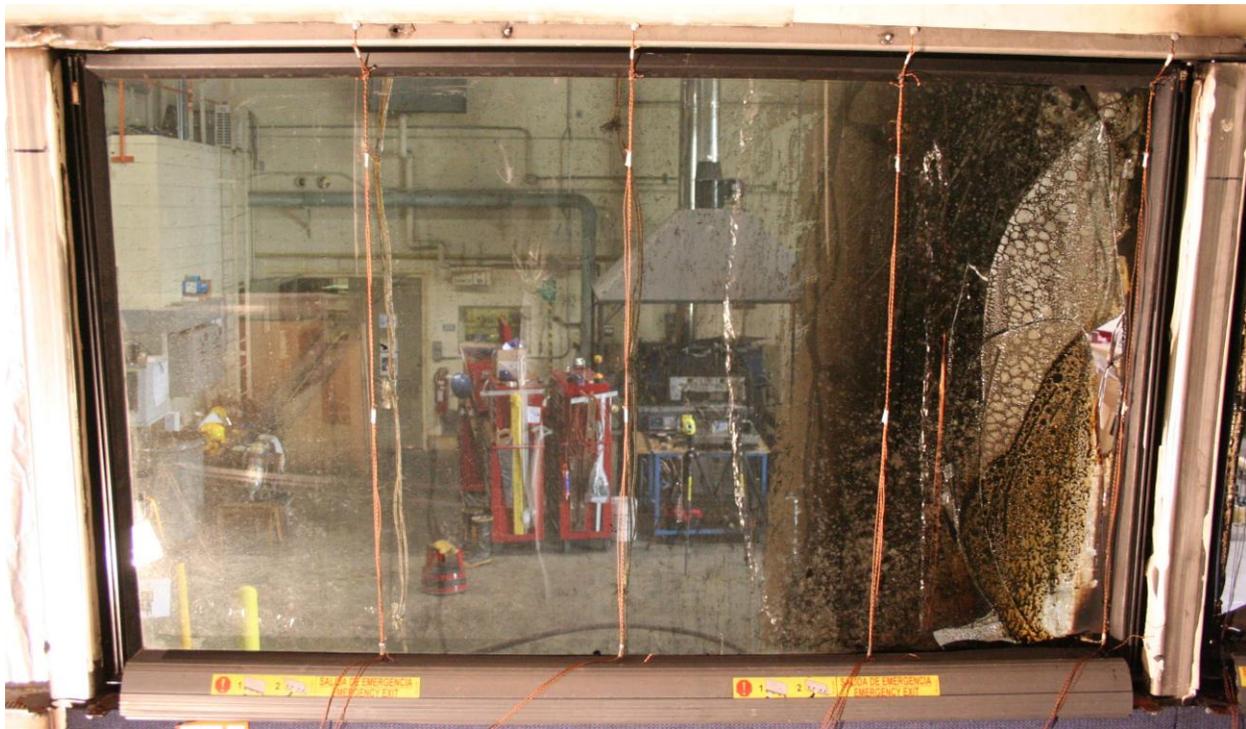
Figure 70 Interior view of damage to the window over the drive axle after the drive axle wheel heating experiment fire.
