Subject: Motorcoach Safety Research

Human Factors Issues in Motorcoach Emergency Egress

YEAR 2 FINAL REPORT

John A. Volpe National Transportation Systems Center
Research and Innovative Technology Administration
U.S. Department of Transportation
Cambridge, MA 02142

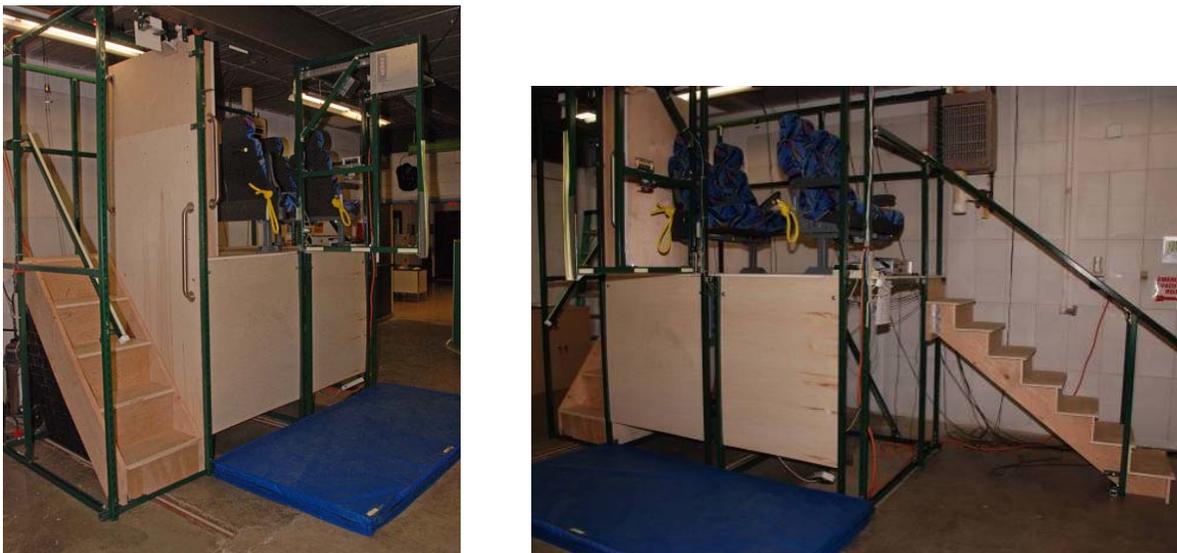
Overall dimensions of the platform floor were 3 m (10 ft) long by 1.5 m (5 ft wide). The mock-up steel frame was constructed of *Superstrut*[®] components. The boarding stair projected an additional 1.8 m (6 ft) from the right end of the platform. The landing mat that subjects jumped onto from the wheelchair-access side door openings measured 1.2 m (4 ft) by 2.4 m (8 ft) by 10 cm (4 in) thick and was constructed from polyurethane foam covered with vinyl.

Figure 2-1. Motorcoach Mock-up – Exterior

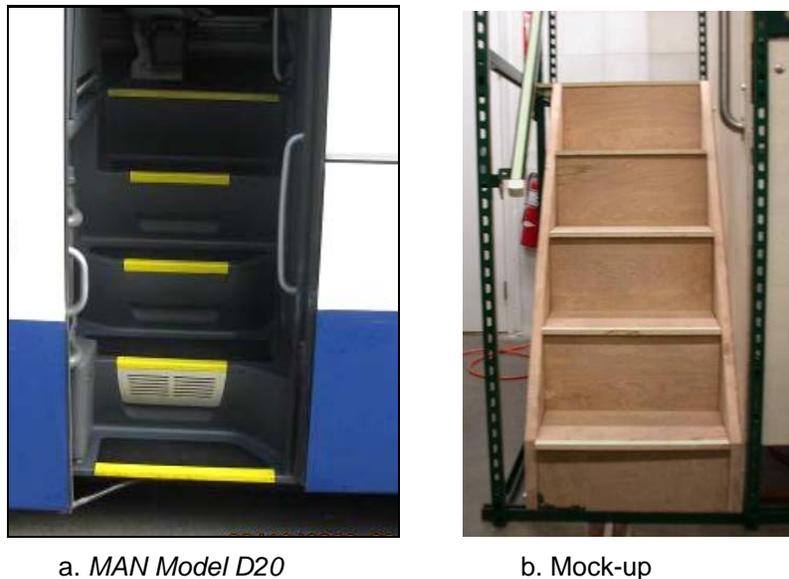
All of the critical dimensions that influence egress rates were replicated from motorcoaches typical of the U.S. fleet. The platform height was 1.52 m (60 in), which is almost as high as the highest floor heights found on U.S. buses. The stairway shown on the right in Figure 2-1, which was used by the subjects to ascend to the platform, had eight 19-cm (7.5-in) risers, providing a slope of 37° – typical of the majority of stairs in modern buildings, which are sloped from 30 to 38° . The left stairway, which simulated the configuration used with a second door on buses operated in other countries, had five 30-cm (12-in) risers and a 50° pitch. This stair run was inherently limited to the width of a pair of seats (i.e., 102 cm [40 in]). The stair treads were 61 cm (24 in) wide. The clearance between hand rails was 57 cm (22.5 in), as measured on a *MAN model D20* bus, shown in Figure 2-2, beside a close-up of the mock-up stairs.

Figure 2-2. Similar Dimensions of Second-Door Stairs in a Bus and Mock-up Stairs

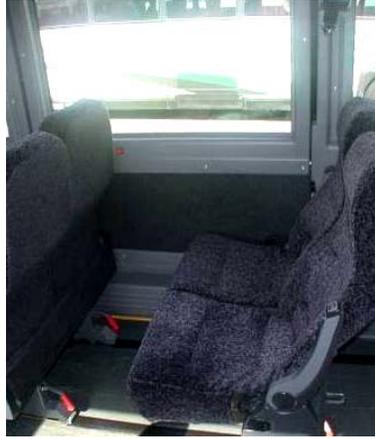
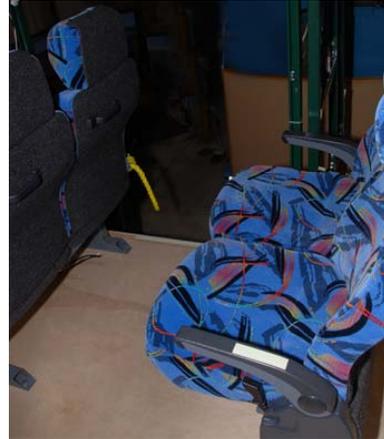
The rear side door opening, modeled on the wheelchair-access door of the *MCI J-4500*, was designated the “Lavatory-Door” because of its location adjacent to the lavatory on the real bus.

Figure 2-3. Similarities of *Prevost X345* Wheelchair-Access Door and Mock-up – Interior

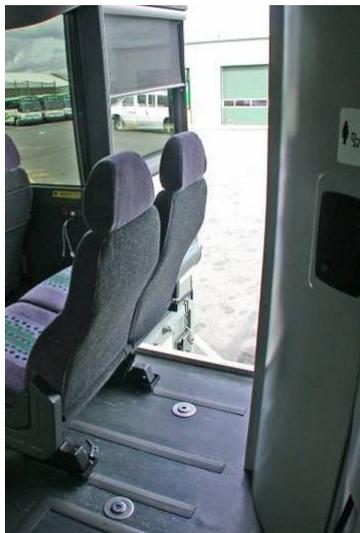
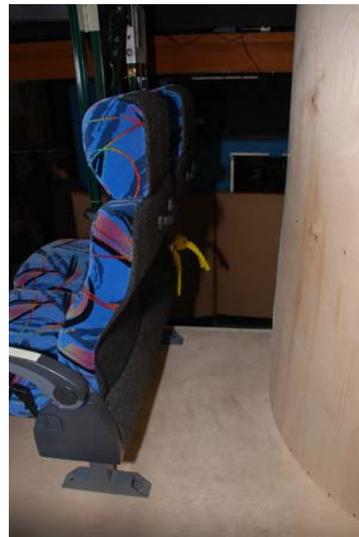
This door was fitted with a side-hinged door that was locked in the full-open position for the egress trials. A curved plywood partition was erected adjacent to the rear opening to duplicate the narrower exit path caused by the lavatory. Figure 2-4 shows the real bus lavatory door and its mock-up opening counterpart.

Figure 2-4. Similarities of *MCI J-4500* Wheelchair-Access Door and Mock-up – Interior

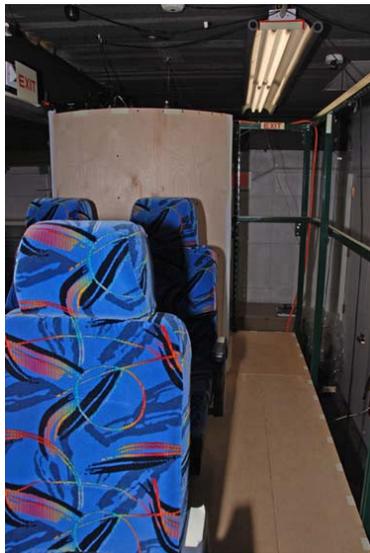
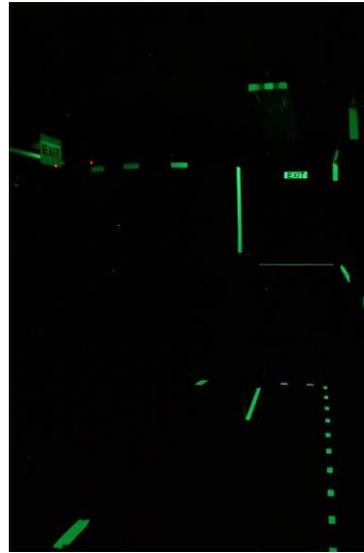
Figure 2-5. Mock-up HPPL Exit Signs and Path Marking – Looking Along Main Aisle

open “Mid-Door” and “Lavatory-Door” of the mock-up, as shown in Figure 2-5, and Figure 2-6 as well as obstacles, such as the edge of the landing mat and the open “Mid-Door.”

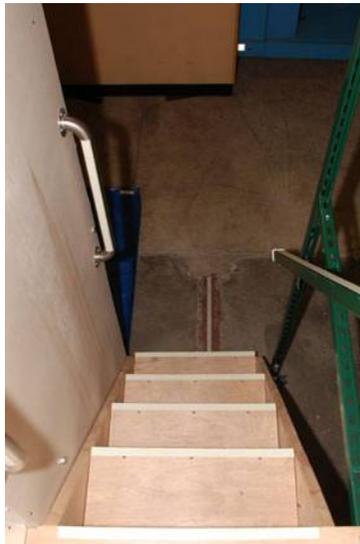
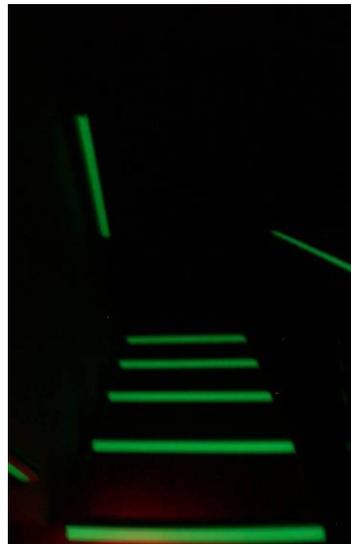
Figure 2-6. Mock-up HPPL Path Marking – Side Stairway

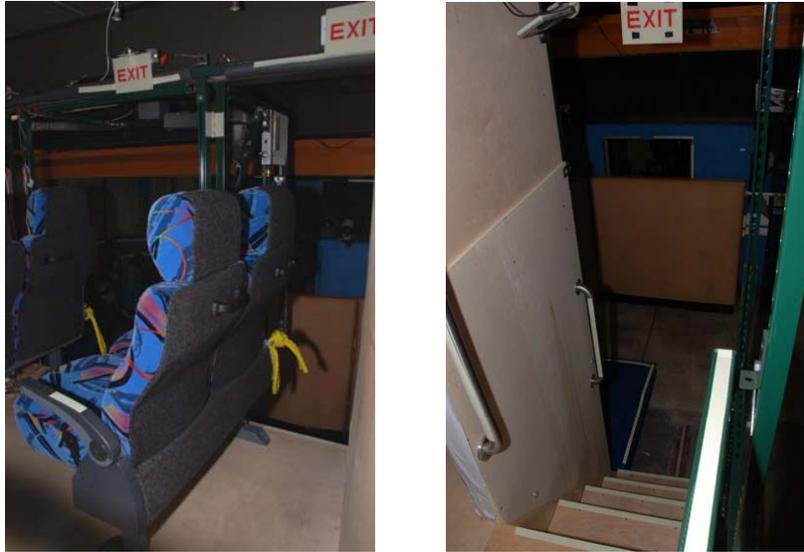
Electrically powered, backlit HPPL material “EXIT” signs with 5-cm (2-in) high letters were located above the “Mid-Door” and “Lavatory-Door,” as well as above the side stairway (see Figure 2-7). Luminaires (“luminaire” is the term used in the lighting industry to describe the combination of a light fixture with its lamp(s), power supply, controller, and housing) were turned on for each egress trial for the respective exit path and illumination level.

Figure 2-7. Mock-up HPPL “EXIT” Side Door and Stairway Signs

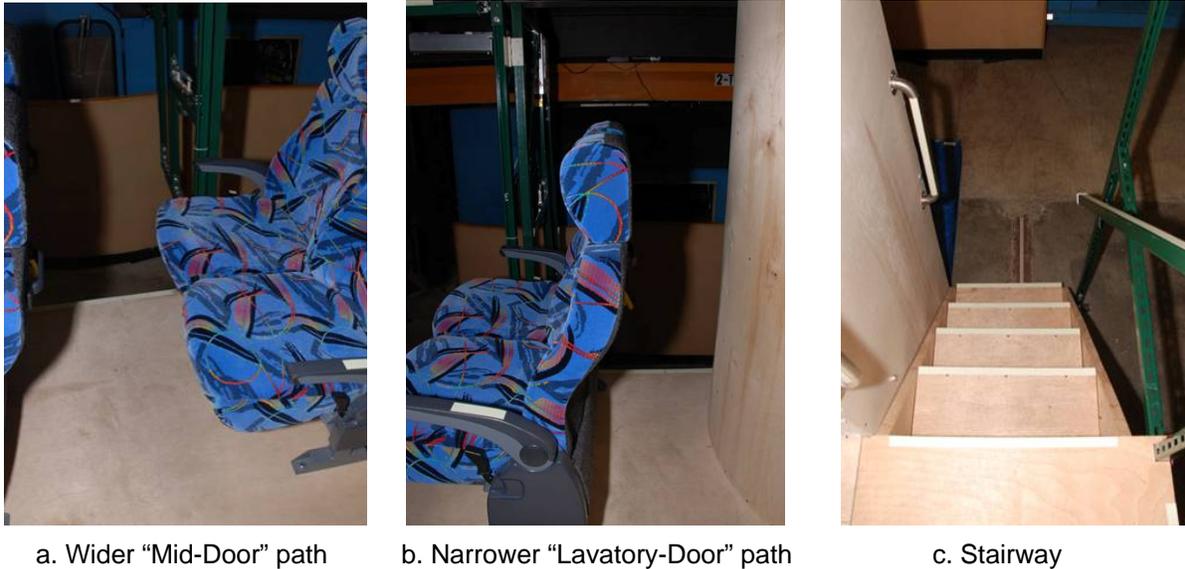
Figure 2-8 illustrates the three exit aisle way paths as seen under normal lighting from the perspective of a person standing in the aisle inside the mock-up. Figure 2-9 shows the perspective of the subjects looking down from the mock-up “Lavatory-Door” and “Mid-Door,” prior to the sitting and controlled drop egress trials.

Figure 2-8. Side-by-Side View of the Three Egress Paths

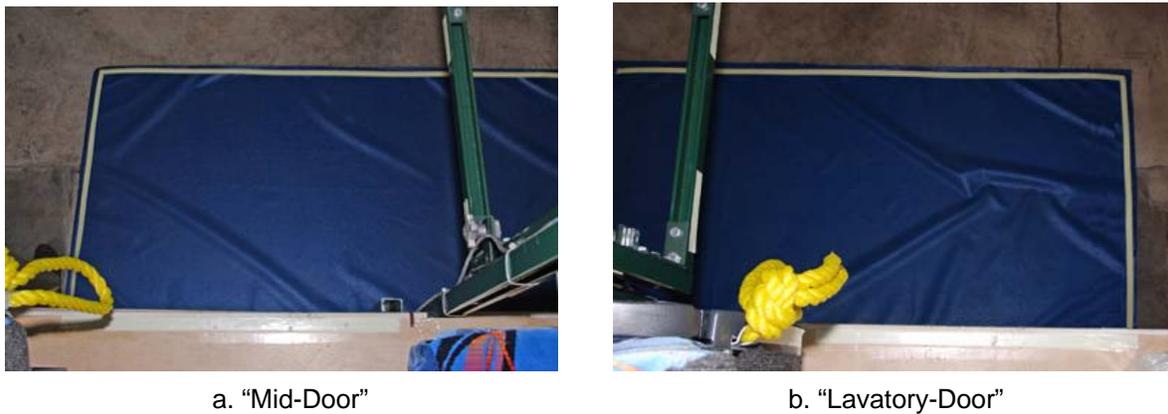
Figure 2-9. Subject View: Exit Openings for Sitting Jump and Controlled Drop—Simulated Wheelchair-Access Door

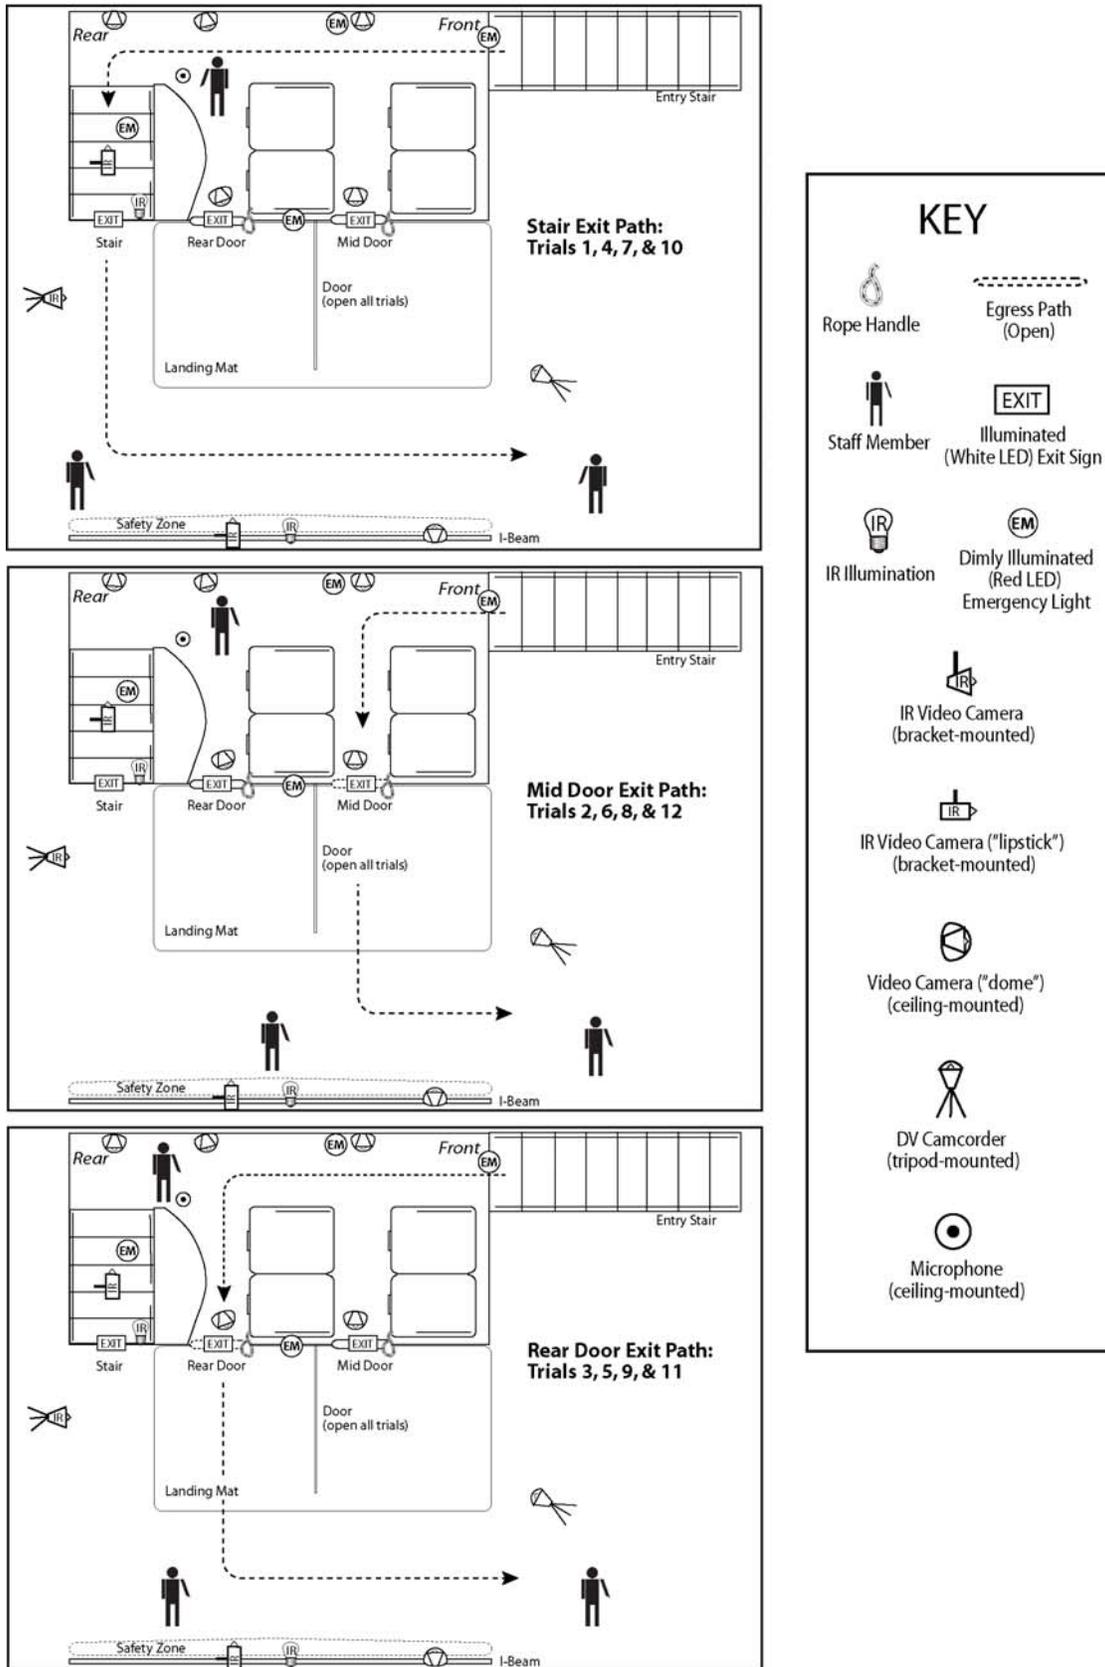
The location of the various mock-up components, cameras, and the three exit paths is shown schematically in Figure 2-10.

Figure 2-10. Bus Mock-up Schematic Diagram

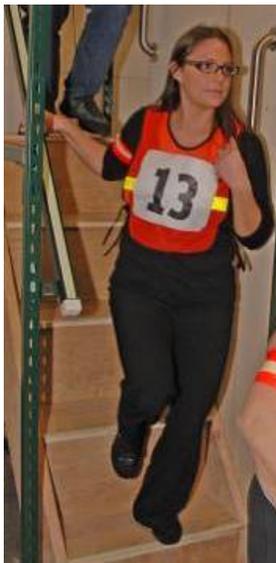
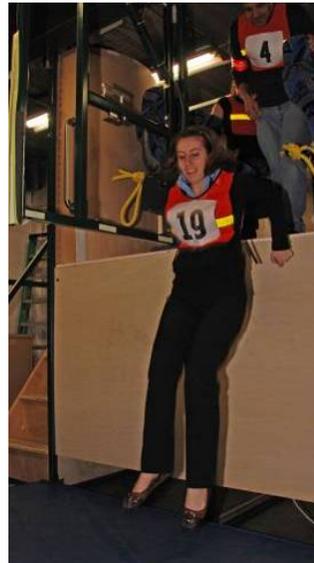
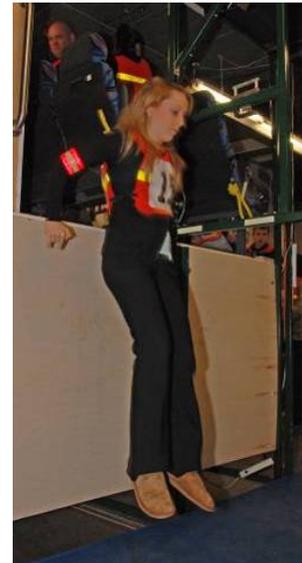
The sitting jump consisted of sitting on the door threshold with the subject’s legs hanging down, and then pushing off with both hands on the sill, so as to retard the rate of fall as much as possible. The controlled drop method was similar except that the rope handhold allowed subjects to retard their rate of fall more than in the sitting jump, and also gave them an additional means of maintaining balance on contact with the landing mat. The three egress paths and methods are illustrated in Figure 2-11 and Figure 2-12.

Figure 2-11. Subject Egress Using Side Stairway and Simulated Wheelchair-Access Doors

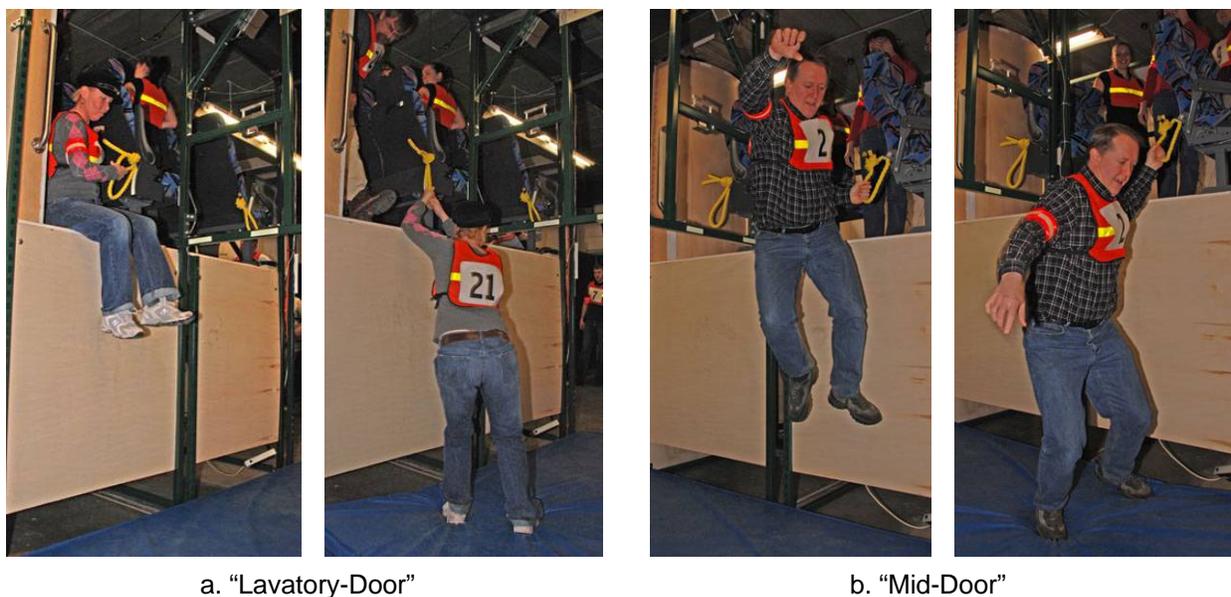
Figure 2-12. Subject Egress Using Simulated Wheelchair-Access-Doors – Controlled Drop

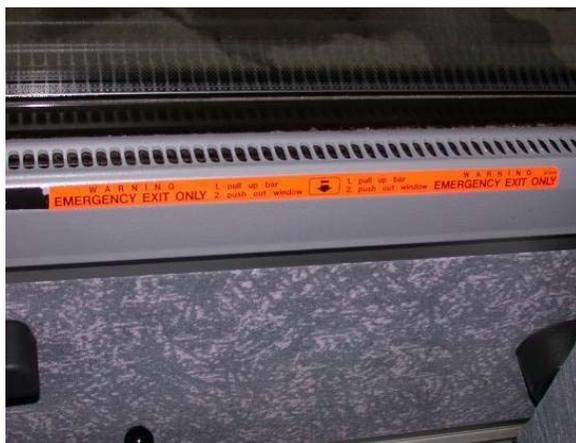
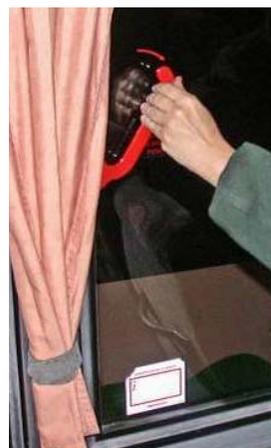
Two fundamentally different types of release mechanisms are in widespread use in the current motorcoach fleet. *MCI* and *Prevost* buses use a bar release that extends across the full width of each emergency exit window, shown in Figure 2-13a. Three samples of this type of mechanism tested during the Year 1 field survey required more than 190 N (43 lbf) to release. The side-mounted, pivoting release lever used on *Van Hool* coaches (Figure 2-13b) generally requires much less force. Because of the pivot action, the required force varies inversely with the distance from the pivot at which the force is applied. Samples measured with force applied near the end of the lever required less than 60 N (14 lbf) to release. Forces of such magnitude are within the ability of the majority of adults who may ride motorcoaches. Only the horizontal release-bar configuration was used for the human strength tests.

Figure 2-13. Emergency Window Exit Releases

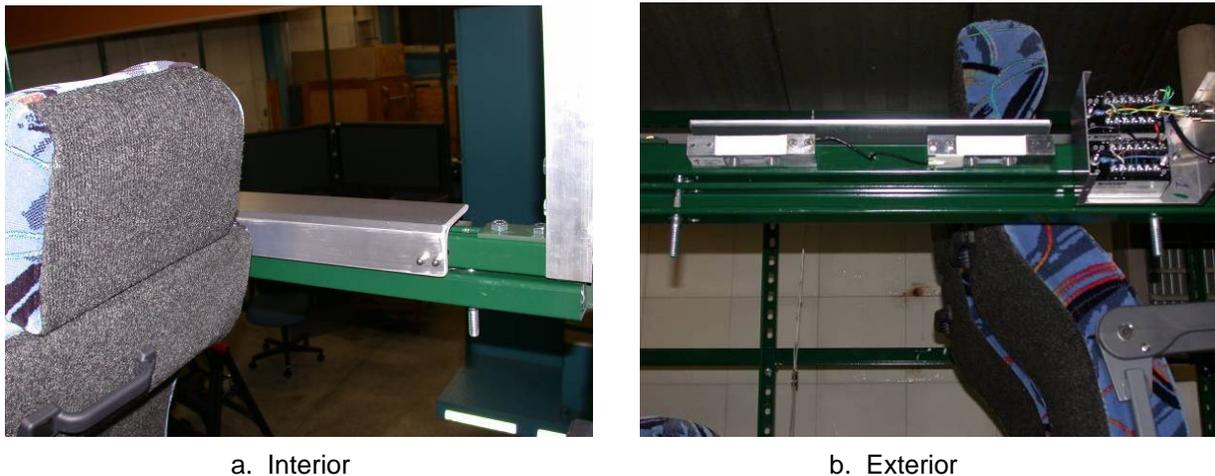
sill was installed in this opening to which the sash could be locked as needed (see Figure 2-14). A pair of *Omega Engineering Model LCAE-100KG* load cells were mounted on the bottom rail of the sash. Two load cells were used to prevent the application of off-axis forces, which would not be measured accurately. Each of these load cells can measure forces of up to 980 N (220 lbf) in either direction. Attached to the load cells by four studs was a 43-cm (17-in) length of extruded aluminum angle stock with cross-sectional dimensions similar to the release bars used on most motorcoach emergency window exits. The studs passed through the sash frame and were not visible in the close-up views from inside and outside shown in Figure 2-14.

Figure 2-14. Close-ups of Apparatus for Measuring Forces Applied to the Window Sash

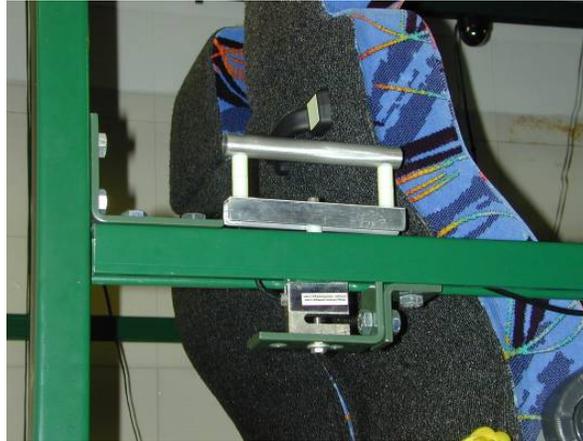
The apparatus to measure strength in applying force to a door release consisted of a pull-handle attached to an *Omega Engineering Model LCCA-200* “S”-beam load cell, as shown in Figure 2-15.

Figure 2-15. Close-up View of Apparatus for Measuring Door-Release Forces

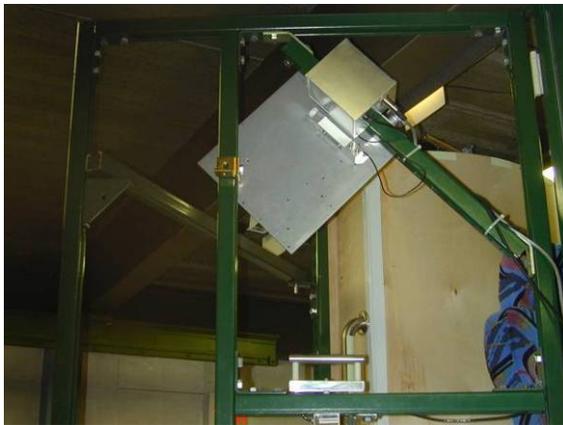
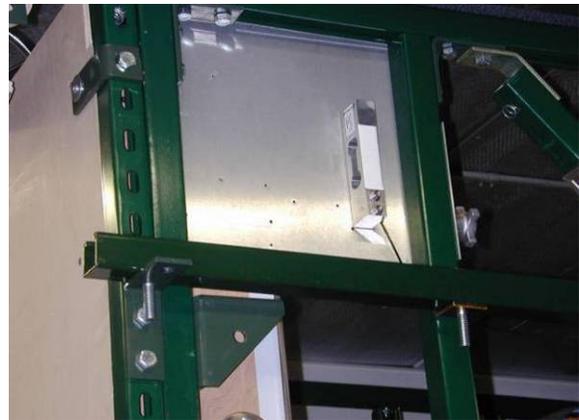
The diameter of the rod to which the subject applies force was 1.9 cm (0.75 in). Measurements of forces applied to push the door outward had to be made at two different locations. When the door was closed, the most effective place to apply opening force was near the rear edge of the door. However, when the door was open by a sufficient amount to provide a 61-cm (24in) clearance in the center of the exit path, it was impossible to reach the edge of the door since it was 107 cm (42 in) wide. Thus, the opening force measurement had to be made at a point that could be reached by an individual standing inside the mock-up and holding onto a seat for leverage. This point was roughly at the center of the door. Accordingly, the force measurement apparatus for these tests was constructed from a sheet of 0.32-cm (1/8-in) aluminum, fitted with a thumbscrew bracket, so that it could be quickly mounted and removed in either the center or the edge of the door, as shown in Figure 2-16.

Figure 2-16. External Views of Apparatus for Measuring Door Pushing Forces

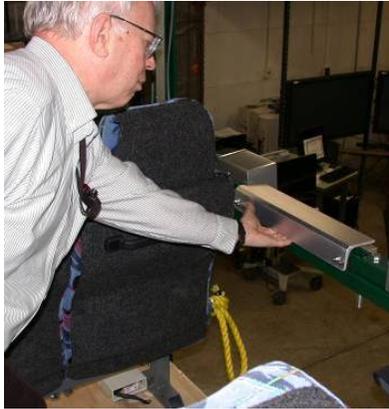
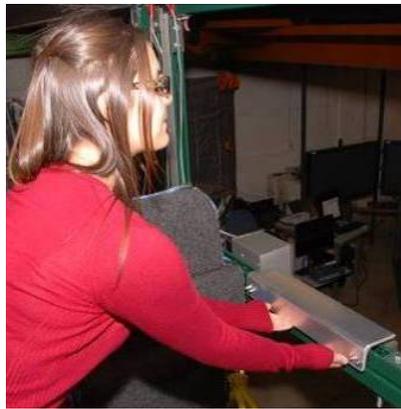
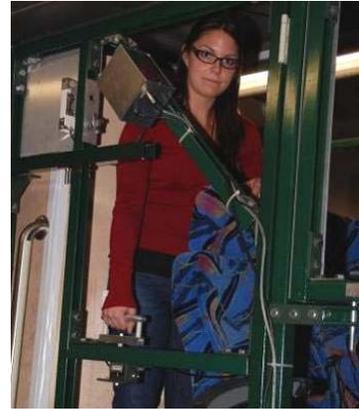
Figure 2-17. Applications of Release (Pulling) Forces

The force applications are illustrated in Figure 2-17 and Figure 2-18.

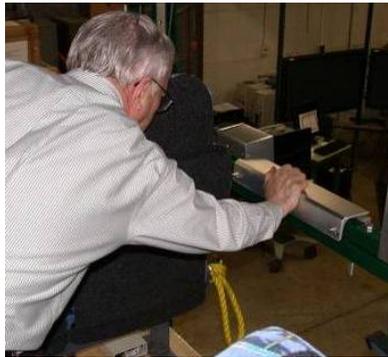
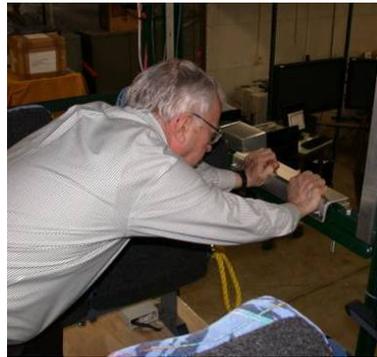
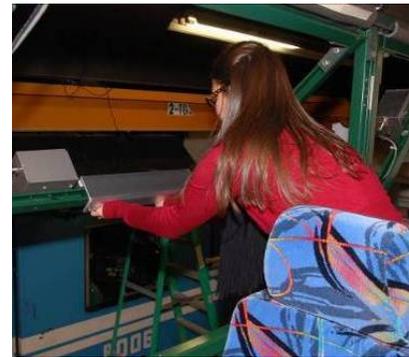
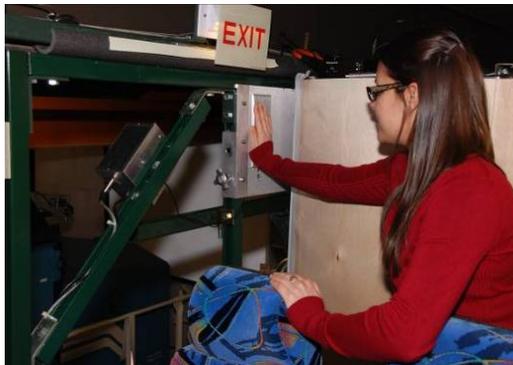
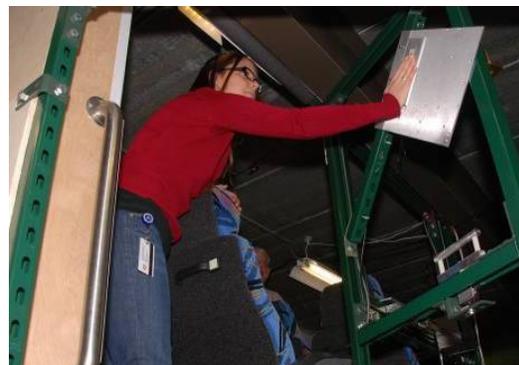
Figure 2-18. Applications of Opening (Pushing) Forces

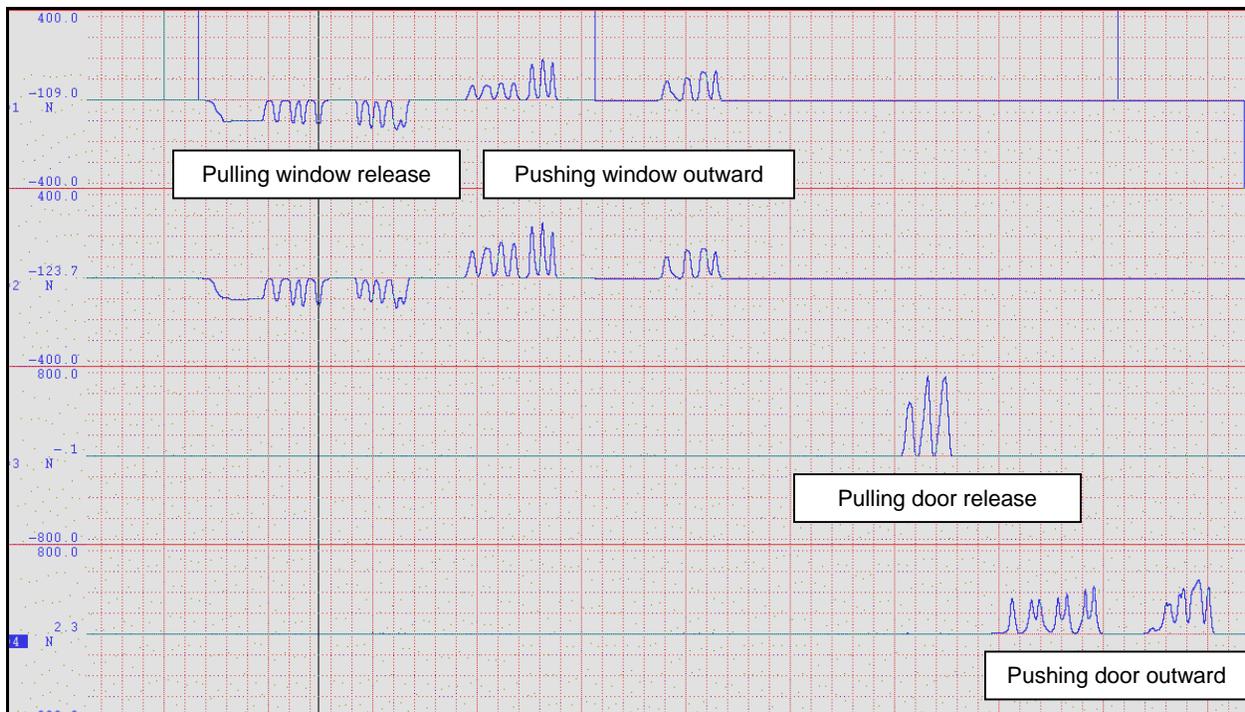
The traces on Channels 1 and 2 (upper two traces in Figure 2-19) represent forces applied to the pair of load cells on the window sash. The negative excursions are pull forces – the first group with one hand, and the second group with two hands. The positive excursions represent pushing forces, the first group being with one hand on a closed window, the second with two hands on the closed window, and the third being a two-handed push with the window open by 51 cm (20 in). The values from Channels 1 and 2 must be summed to determine the total forces applied to the window sash. The trace on Channel 3 (third from top in Figure 2-19) represents pulling forces on the door-release handle. The first group of excursions on Channel 4 (bottom trace in Figure 2-19) represents pushing on the closed door with the sensor near its edge, and the second group represents forces applied to the sensor mounted near the lateral center of the door with the door open by 61 cm (24 in), as measured at the center.

Notes: Vertical axis represents applied force in Newtons (N).

Horizontal axis represents time (1.5 seconds per division).

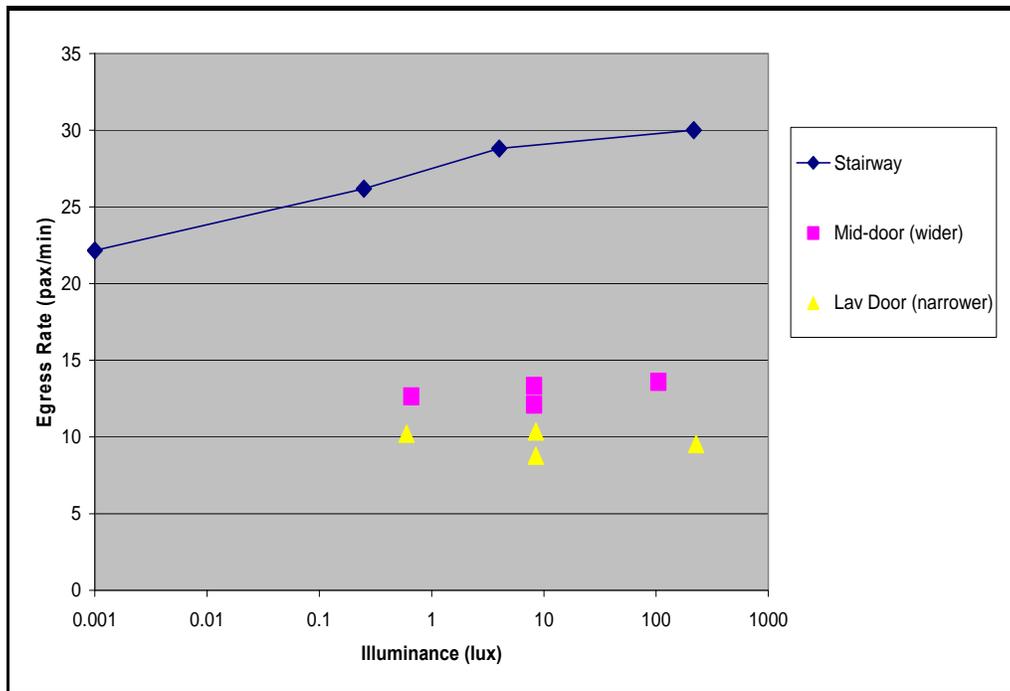
This equation was fitted to the data points in the top line in Figure 3-1, which range from 22 ppm under HPPL marking only to 30 ppm in the normal light condition. Review of the video recording showed the difficulties that many subjects had in fitting through the narrow space of the simulated wheelchair-access doors, creating between 2 to 4 sec per person delay, depending on the path. Subjects in the Volpe Center 2008 pilot motorcoach egress experiment were able to egress through an unobstructed wheelchair-access door at the rate of 25 ppm, or one every 2.4 sec. Interpersonal intervals through the partially obstructed doorways of this 2009 egress experiment increased to almost 5 sec for the wider “Mid-Door” path and 6 sec for the narrower “Lavatory-Door” exit path. These results should be interpreted with caution, owing to the small sample size and the fact that the experiment subjects were self-selected to be confident of their abilities to drop down from the wheelchair-access doors, which requires greater physical fitness than descending the stairway. As noted previously, the egress of the 24 subjects was not blocked by a wheelchair and the egress trials did not consider how much time it would take to evacuate a person who uses a wheelchair.

Figure 3-1. Comparison of Egress Rates across All Trials by Egress Path and Lighting Level

There was no apparent effect from changing illuminance levels for egress from the two wheelchair-access doors by the subjects, although the absolute “pitch dark” condition (using only HPPL path marking) was not tested due to concern for risk of injury.

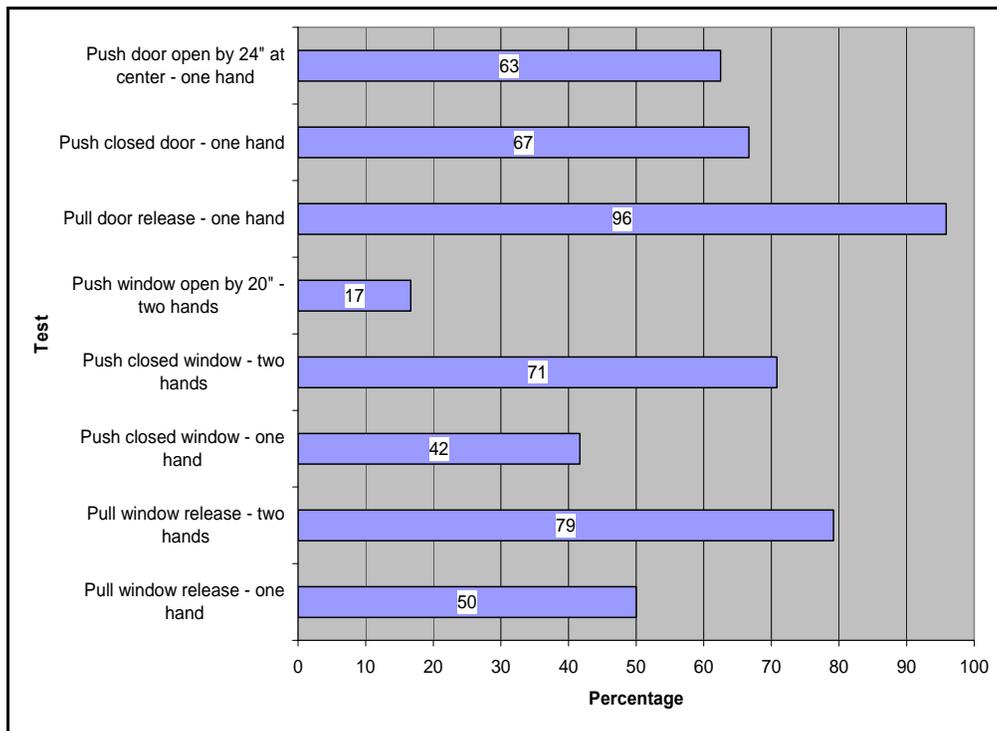
Figure 4-1. Percentages of 24 Subjects Able to Apply a Force of 268 N (60 lbf) or More

A comparison of Figure 4-1, Figure 4-3, and Figure 4-4 shows how reducing the maximum allowable opening force limits from 268 N to 222 N or 178 N would have increased the proportions of the subject population able to operate the exits.

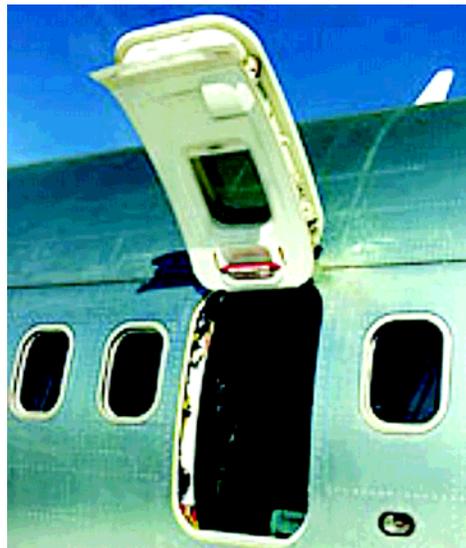
To comply with structural strength requirements, aircraft over-wing emergency exits can weigh as much as 29 kg (65 lbs). The NTSB documented cases where use of those heavy over-wing exits caused difficulties in emergency evacuations, such as passenger delay in opening those exits and stowing the hatch.¹⁶ The NTSB also noted that Boeing has a new over-wing exit for its 737 series airplanes based on human factors principles. The exit is hinged and opens outward as passengers would intuitively expect (shown below in Figure 4-2). It is spring loaded so that passengers are not required to exert any force to lift it. This design also eliminates the problem of where to stow the exit hatch because it moves up and out of the egress route. In short, the design eliminates any guesswork about how the exit operates or what to do with the exit hatch once it is opened.

Figure 4-2. New Design Type III Exit for Boeing 737-600, 700, 800, and 900 Aircraft

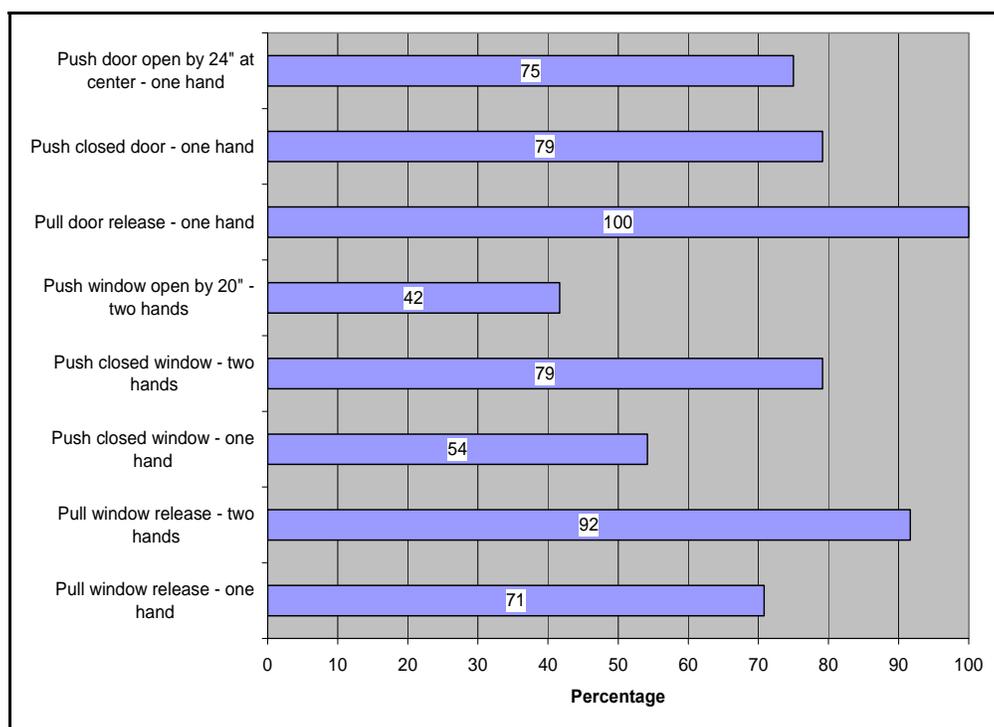
If the maximum forces needed to operate motorcoach emergency exits were 222 N (50 lbf), the proportions of subject individuals who could apply such forces would be increased to the values shown in Figure 4-3.

Figure 4-3. Percentages of 24 Subjects Able to Apply a Force of 222 N (50 lbf) or More

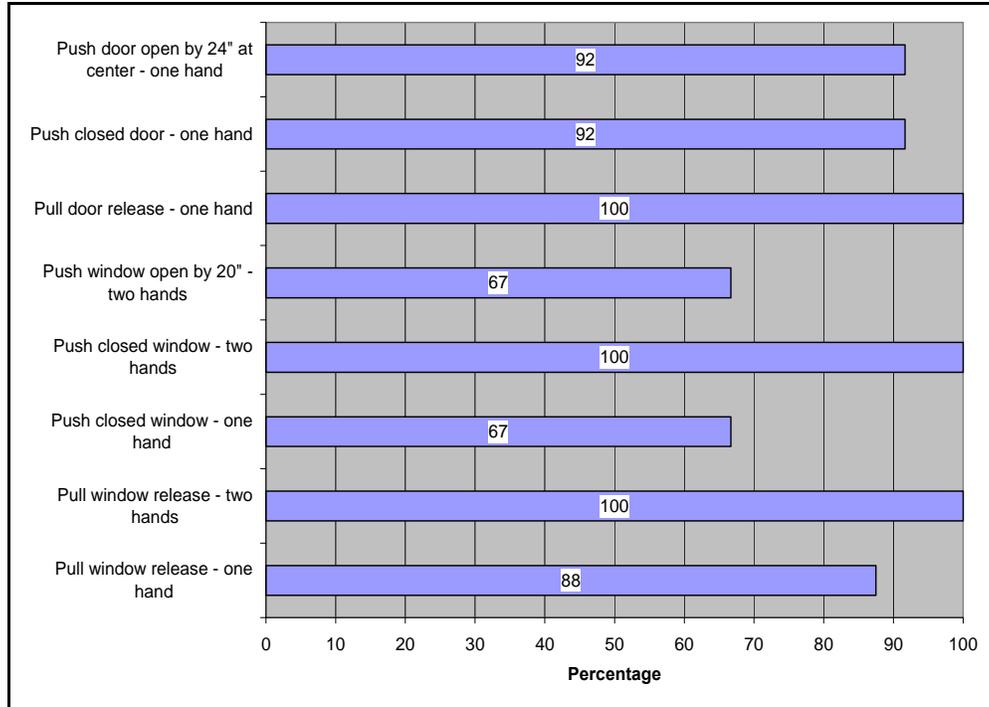
For school buses, FMVSS 217 limits the maximum forces in the high force areas for releasing and opening emergency exits to 178 N (40 lbf). If these limits were applied to motorcoaches, the percentages of the experimental subjects who would be able to meet or exceed those limits would increase further to the values shown in Figure 4-4.

Figure 4-4. Percentages of 24 Subjects Able to Apply a Force of 178 N (40 lbf) or More

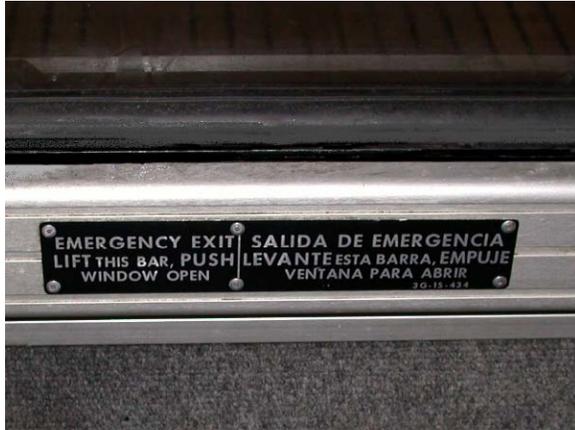
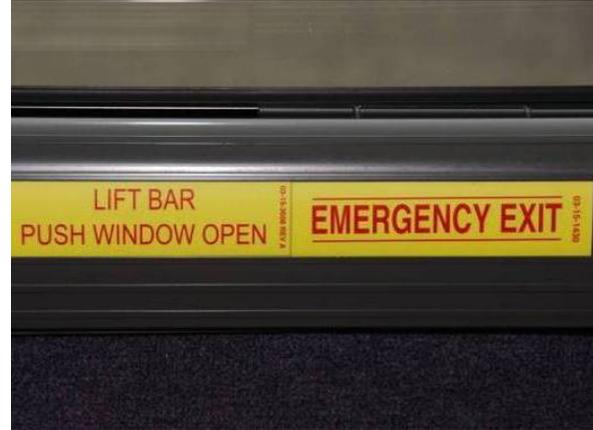
Figure 5-1 and both emergency exit windows in Figure 5-2 show motorcoach emergency exit signs and instructions with larger letter size and bright color with high contrast background compared to the left photo in Figure 5-1.

Figure 5-1. Motorcoach Emergency Exit Window Marking and Instructions (1)

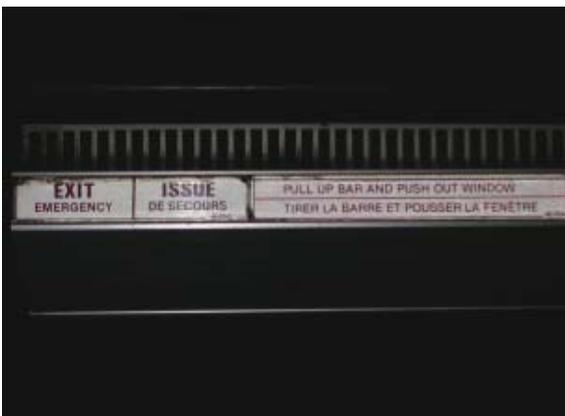
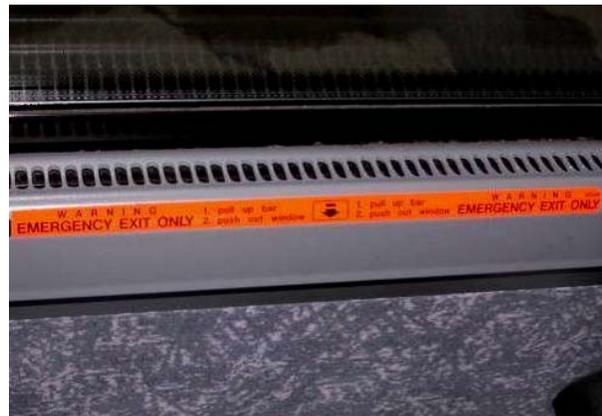
Figure 5-2. Motorcoach Emergency Exit Window Marking and Instructions (2)

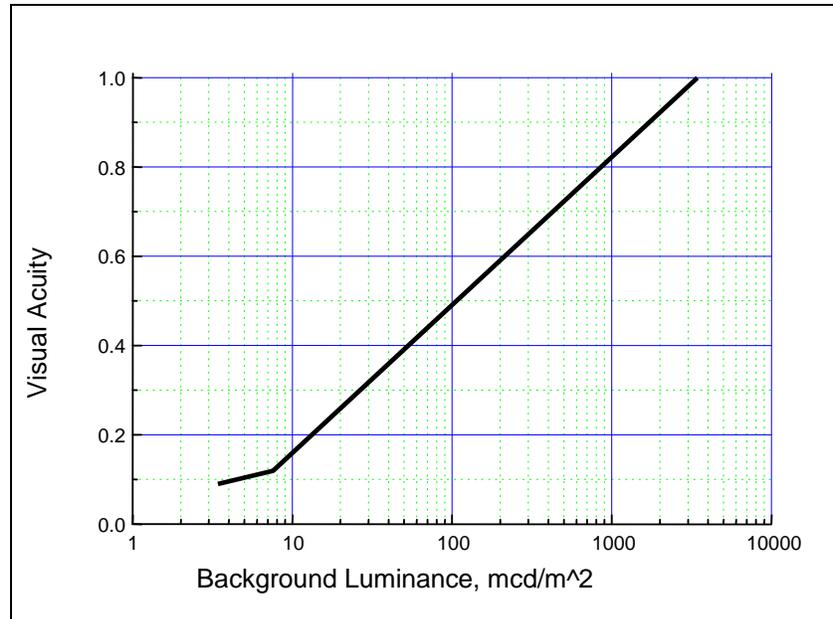
Visual acuity degrades with the luminance of the object being observed, but the human eye adapts so well that even a 10,000-fold reduction in available light causes only a 90% reduction in acuity (see Figure 5-3). This means that there is no sharp demarcation between conditions in which there is sufficient light for emergency exit sign legibility and those in which there is not.

Note: Visual acuity of 1 = 20/20 on Snellen scale; 0.1 = 20/200 Snellen.

Figure 5-3. Human Visual Acuity as a Function of the Luminance of the Observed Object

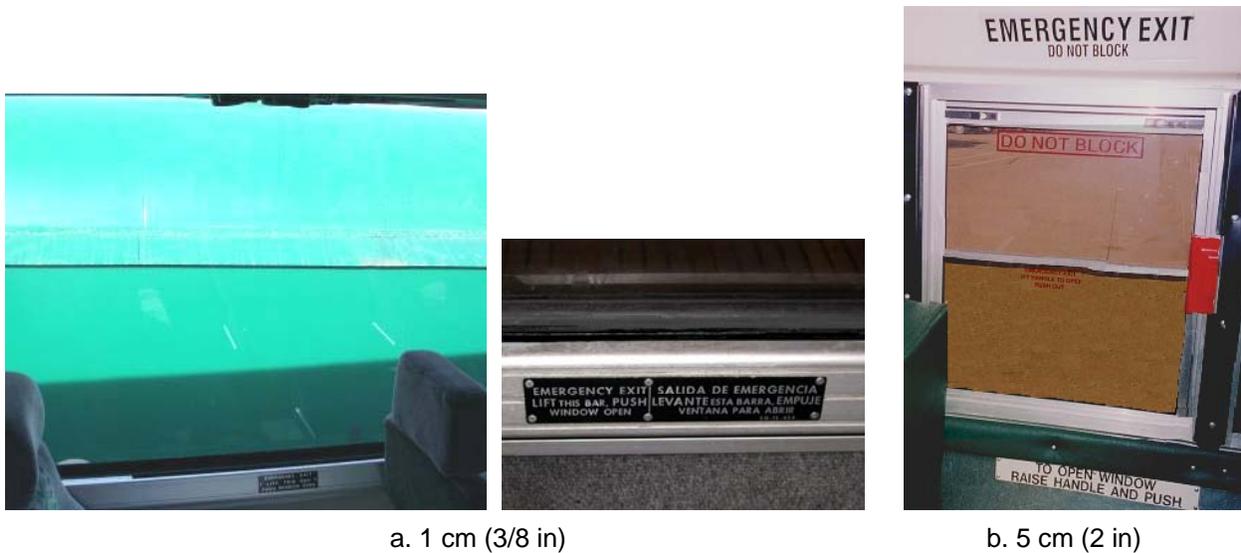
Figure 5-4. Motorcoach and School Bus Emergency Exit Signs – Letter Height

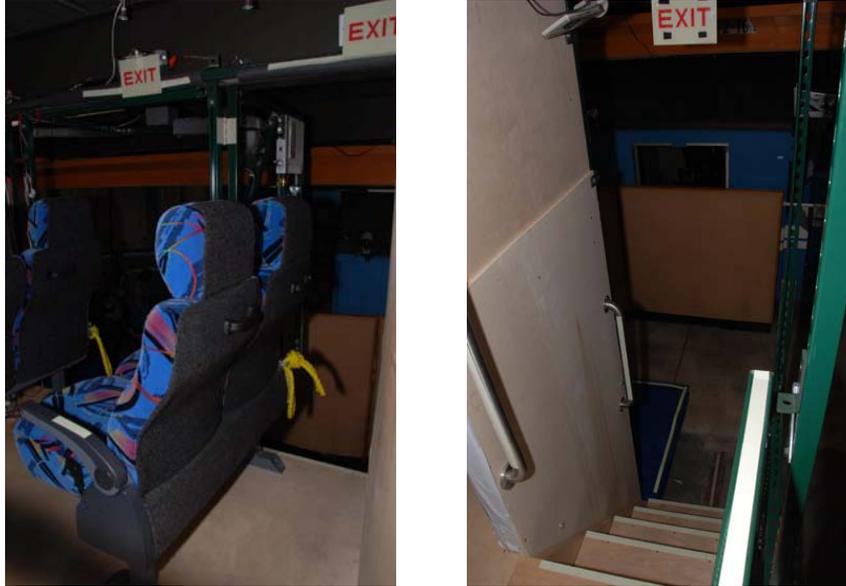
Illuminance tests conducted on these "EXIT" signs showed that even the emergency luminaire with the least light output rated at 10 lumens (providing an illuminance of at least 8 lux (.7 foot-candles (fc)) on the floor directly below the exit opening) illuminated the signs at values of 0.5 to 500 lux (0.05 to 50 fc), depending on the specific placement of the sign with respect to the lamp. For some measurements, the sign was attached about 30 cm (1 ft) below the luminaire, as though mounted on the window exit glass. The "EXIT" signs were observed by Volpe Center staff to be readily visible from a distance of 6 m (20 ft), even for the lowest illuminance condition.

Figure 5-5. Illuminated / HPPL Wheelchair-Access Door and Side Stairway “EXIT” Signs

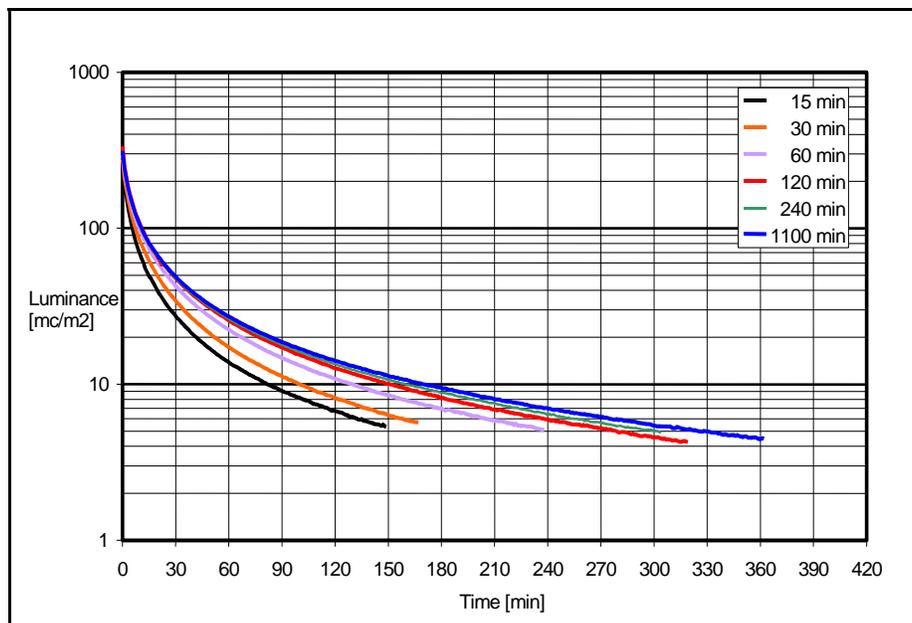
Volpe Center staff recently conducted long-duration measurements of various samples of emergency exit signage that conform to the APTA emergency signage standard luminance criteria for new passenger rail equipment. These samples were charged at an illuminance of only about 11 lux (1 fc), which approximately corresponds to the illuminance present at motorcoach window sills when the adjacent reading light is the only source of illumination. “HPPL-1” sample charging durations are specified in Figure 5-7.

Note: The horizontal axis is time in the dark.

Figure 5-6. “HPPL-1” Sample Luminance Decay and Charging Time – 54 lux (about 5 fc)

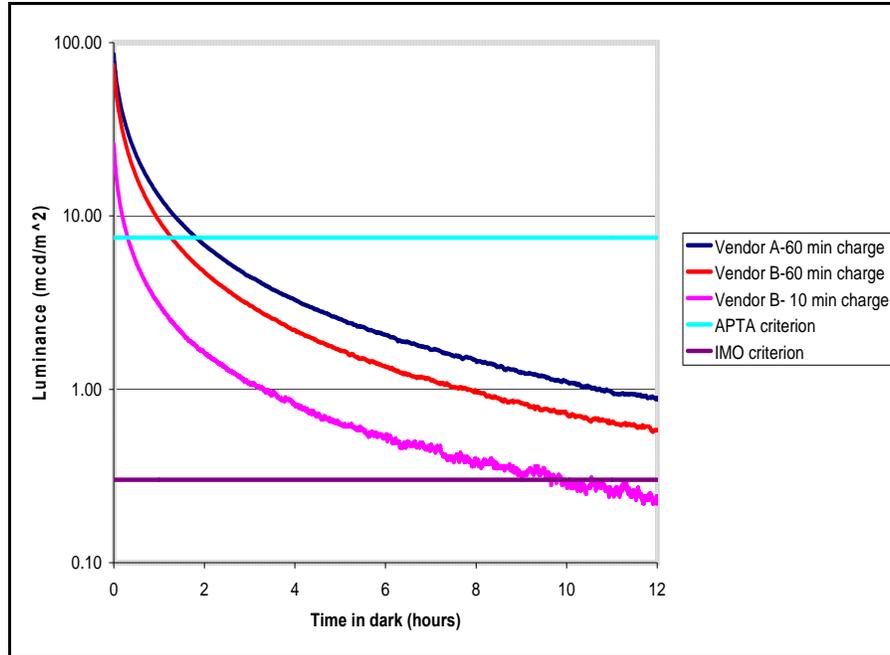
Figure 5-7. “HPPL-1” Sample Luminous Decay and Charging Light – about 11 lux (1 fc)

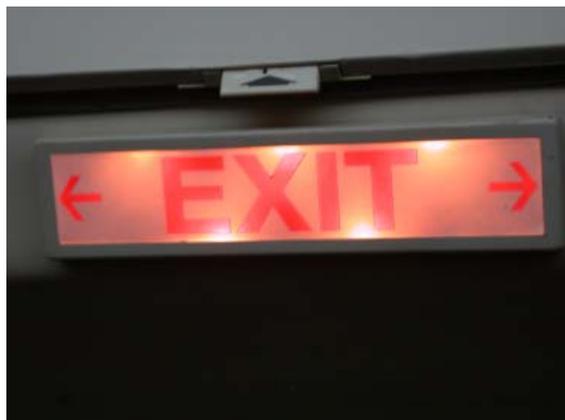
Figure 5-8. Aircraft Electrically-Illuminated Emergency Exit Sign
