Subject: Motorcoach Safety Research

Human Factors Issues in Motorcoach Emergency Egress

YEAR 2 FINAL REPORT

John A. Volpe National Transportation Systems Center
Research and Innovative Technology Administration
U.S. Department of Transportation
Cambridge, MA 02142

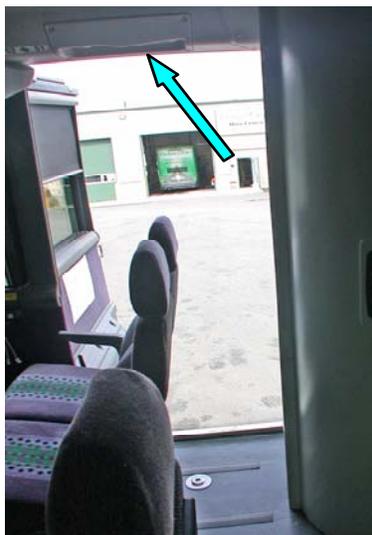
For externally illuminated signs, an emergency luminaire with a minimum output of at least 10 lumens (see Chapter 6 for additional discussion), located within 0.5 m (1.6 ft) of the motorcoach emergency exit sign, would provide sufficient illumination for the sign to be visible at a distance of 6 m (20 ft), provided that some of the light was directed toward the sign surface. For example, if one of the existing lights over the wheelchair-access door (see Figure 5-9) were modified to function as an emergency light, it would provide sufficient illumination to make an emergency exit sign mounted on that door (or other service door) or on nearby emergency window exit glazing readily visible to persons standing in the aisle and persons seated adjacent to or across the aisle from the seat. Moreover, for an overhead emergency luminaire that

Figure 5-9. Overhead Lighting Fixture Located above Wheelchair Access Door

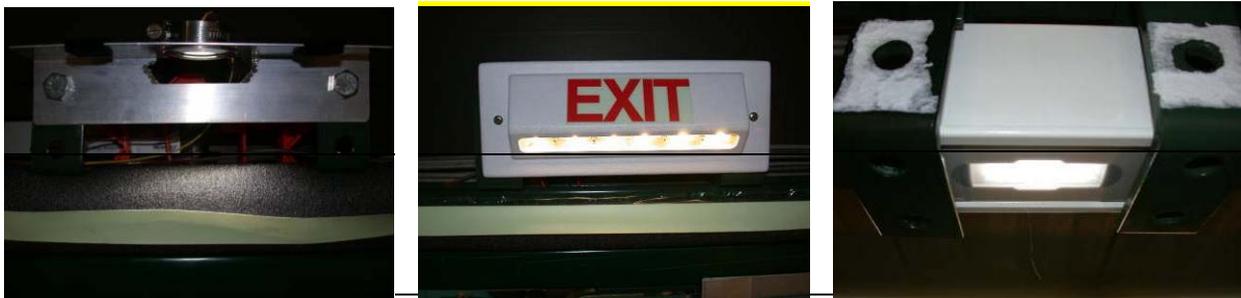
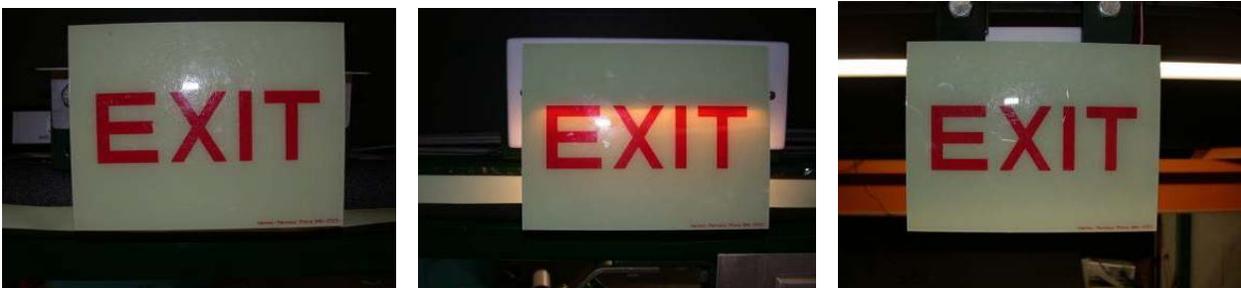
Figure 6-1 shows the lighting devices used in the bus mock-up egress rate experiments without their sign covers and with the HPPL signage overlay. The lighting device characteristics are listed in Table 6-1. All exit sign devices used white LEDs. (In addition, emergency lighting was also provided during certain egress trials by red LED luminaires located above the top of both mock-up stairways, above the rear seat assembly (next to the Lavatory Door) and above the mock-up aisle walkway opposite the Mid-Door (see Figure 2-1.)

Without photoluminescent overlays

With photoluminescent overlays

Figure 6-1. Illuminated / HPPL Wheelchair-Access Door and Side Stairway “EXIT” Signs
