Subject: Motorcoach Safety Research

NIST Technical Note 1653

**Motorcoach Flammability Project
Interim Report: Tire Fire Penetration
into the Passenger Compartment**

April 2010

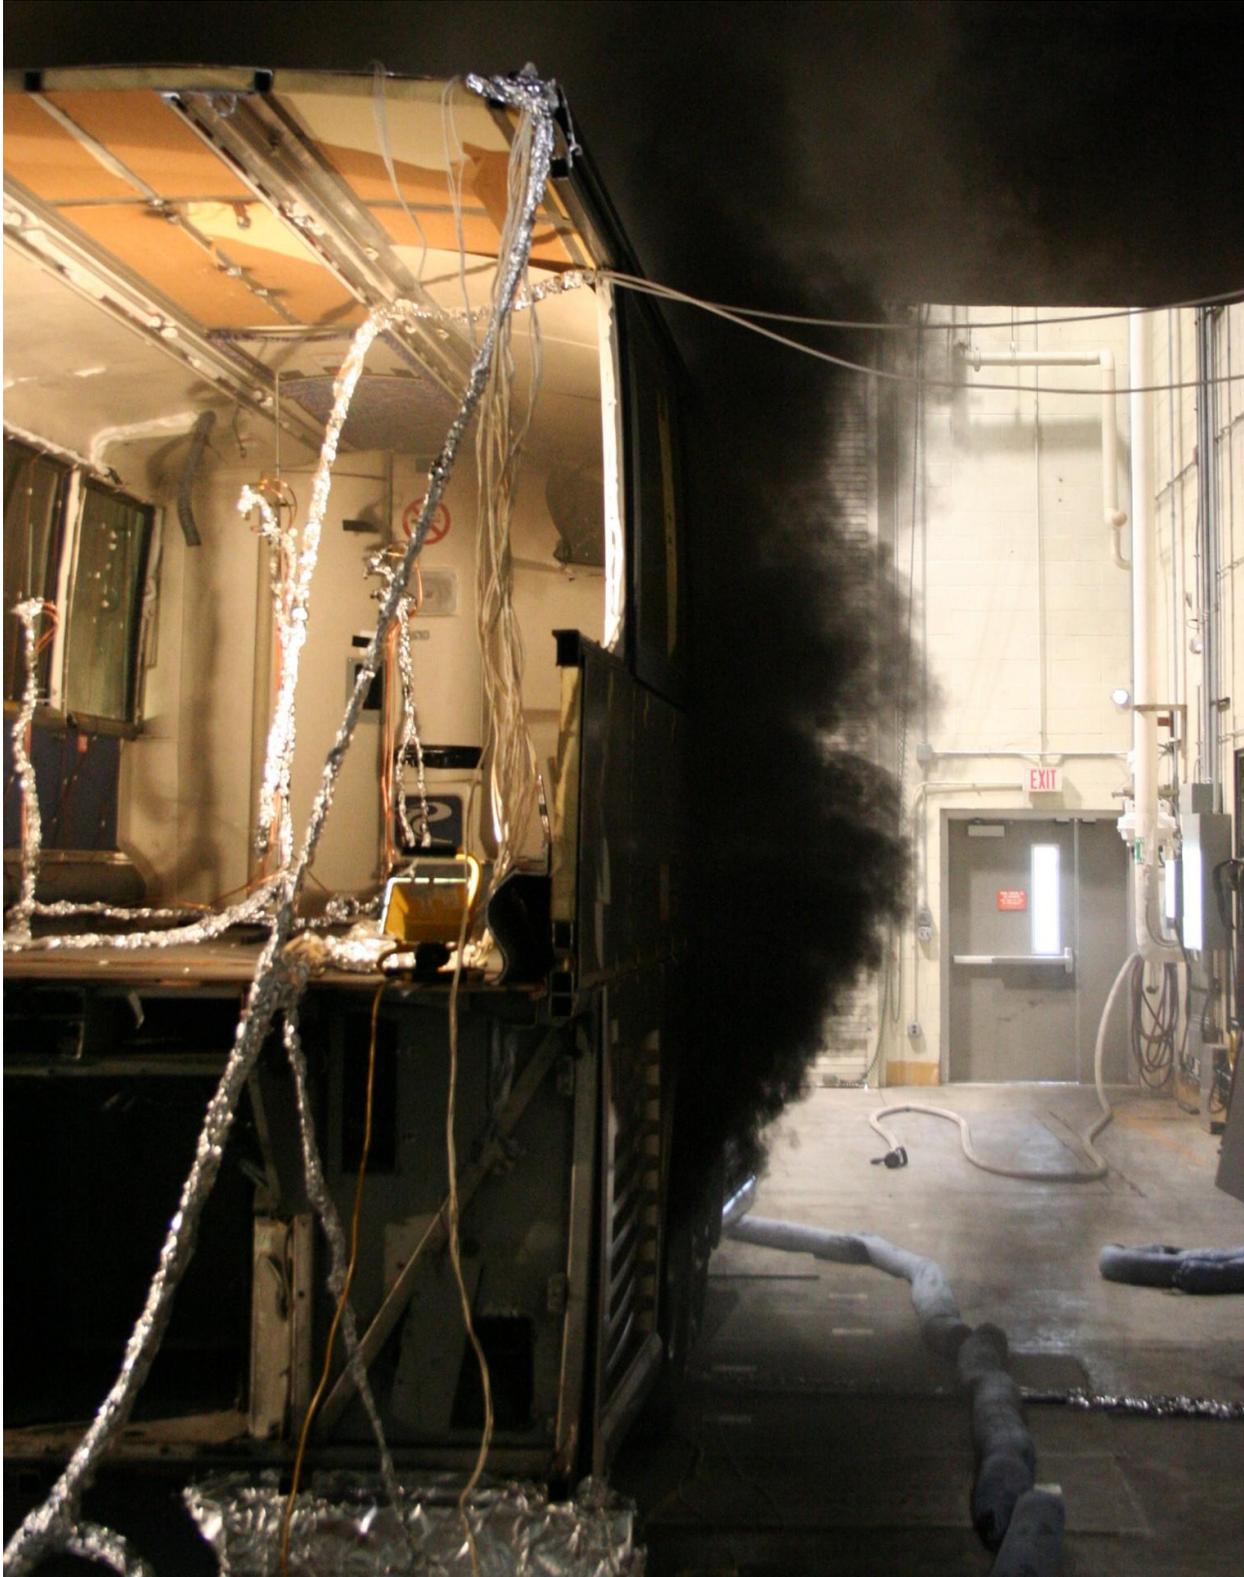
Figure 44 Tag axle wheel heating experiment about 2.5 minutes after the burner was removed showing the large quantity of black smoke on the far (driver's) side of the motorcoach.

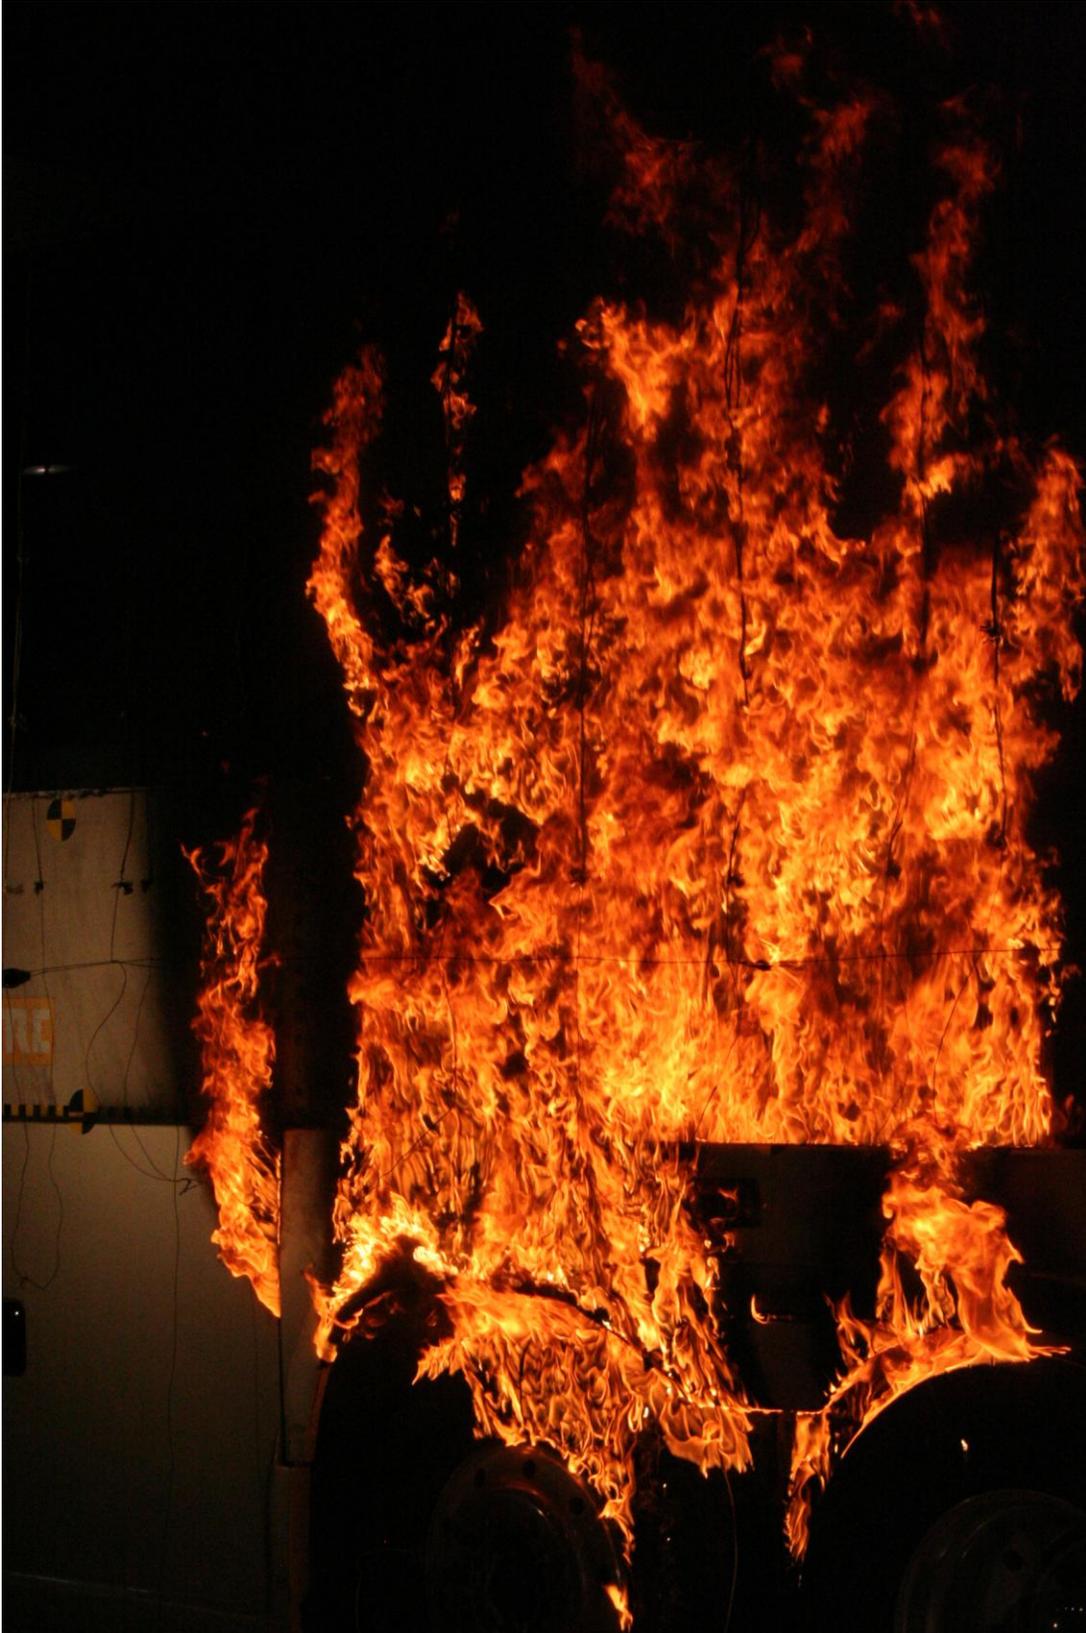
Figure 45 Tag axle wheel heating experiment just under 4 min after the burner was removed.

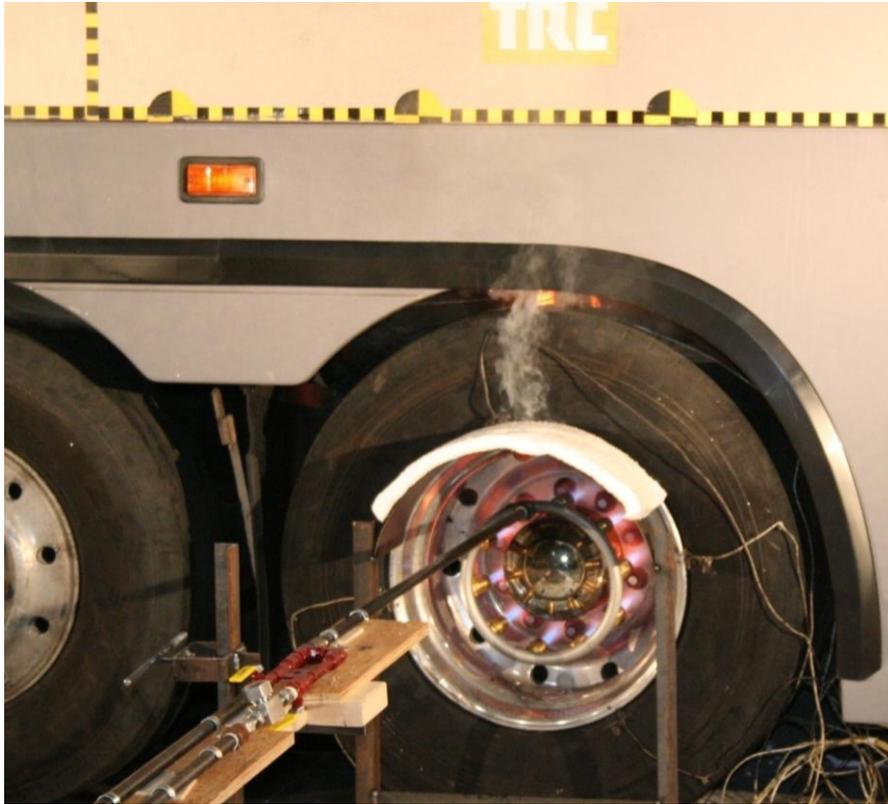
Figure 55 Drive axle wheel heating experiment about 1 min before burner was turned off.

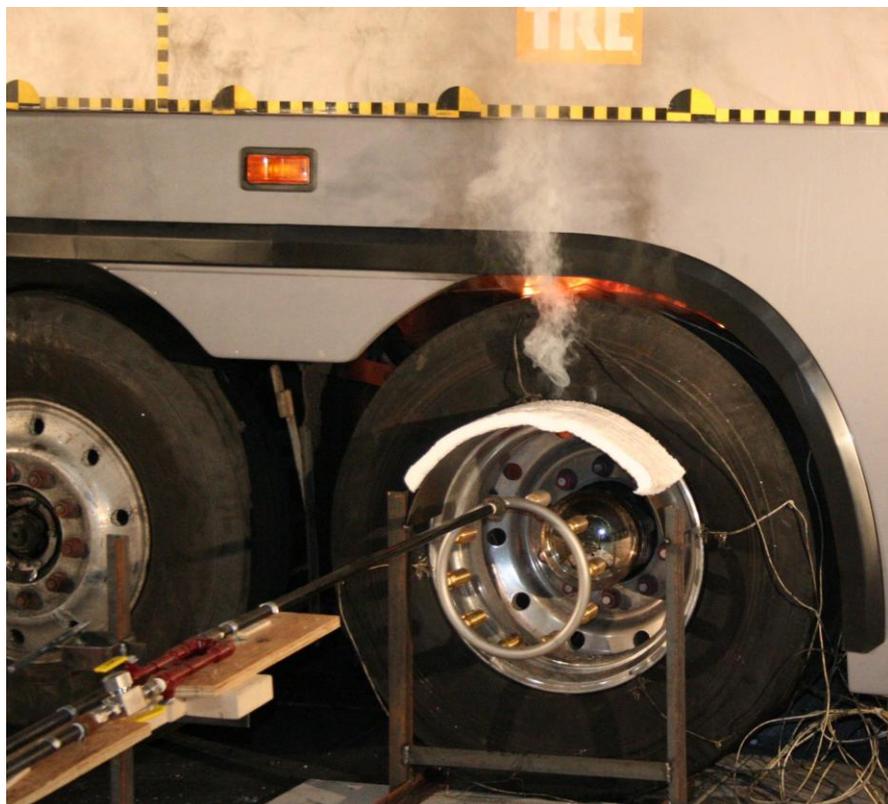
Figure 56 Drive axle wheel heating experiment just after burner was turned off.

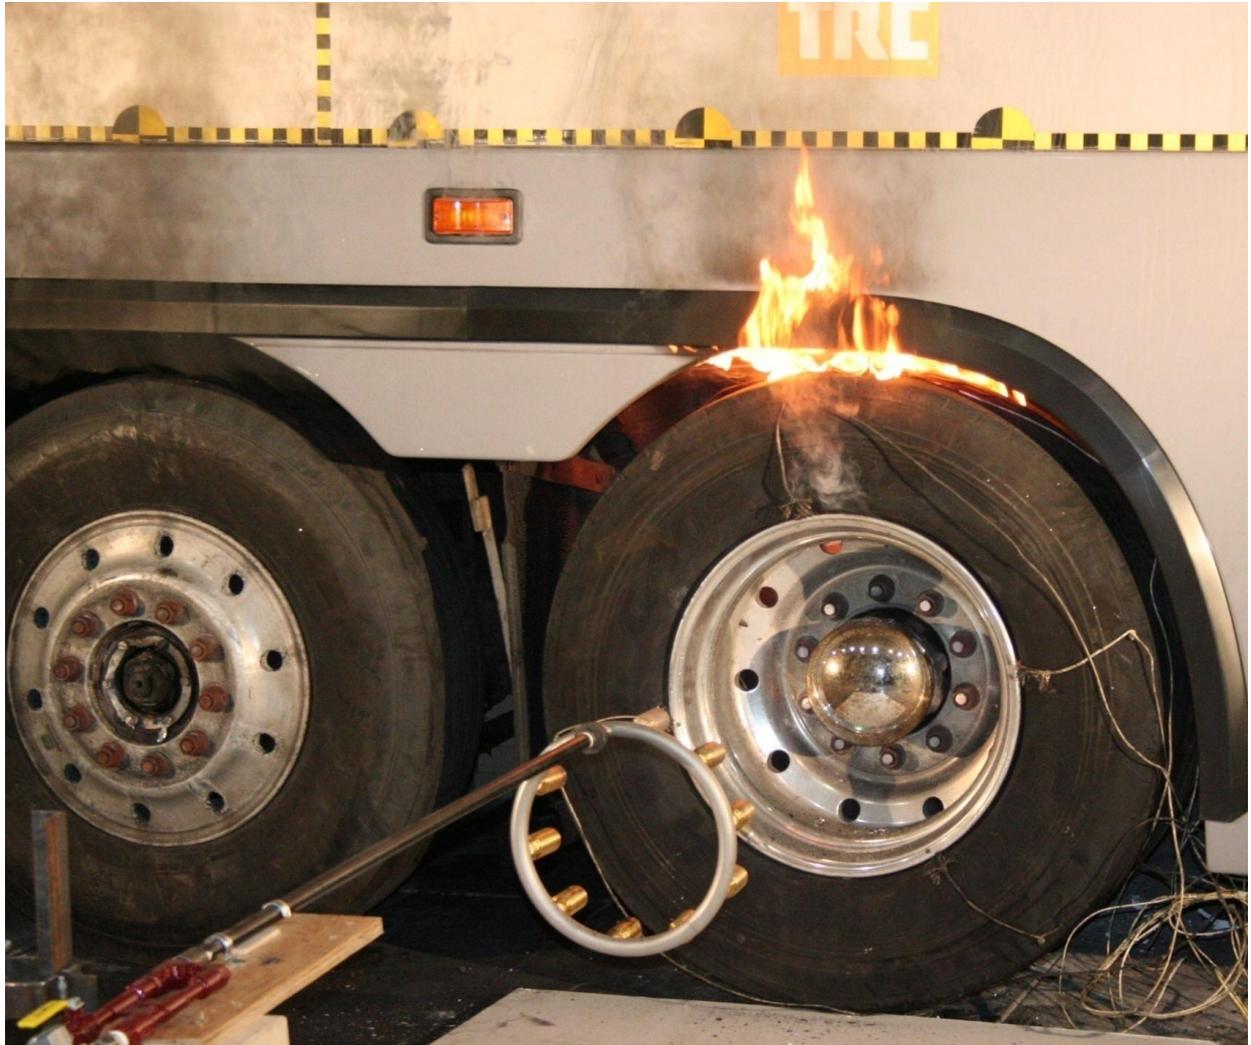
Figure 57 Drive axle wheel heating experiment about 30 s after burner was turned off.

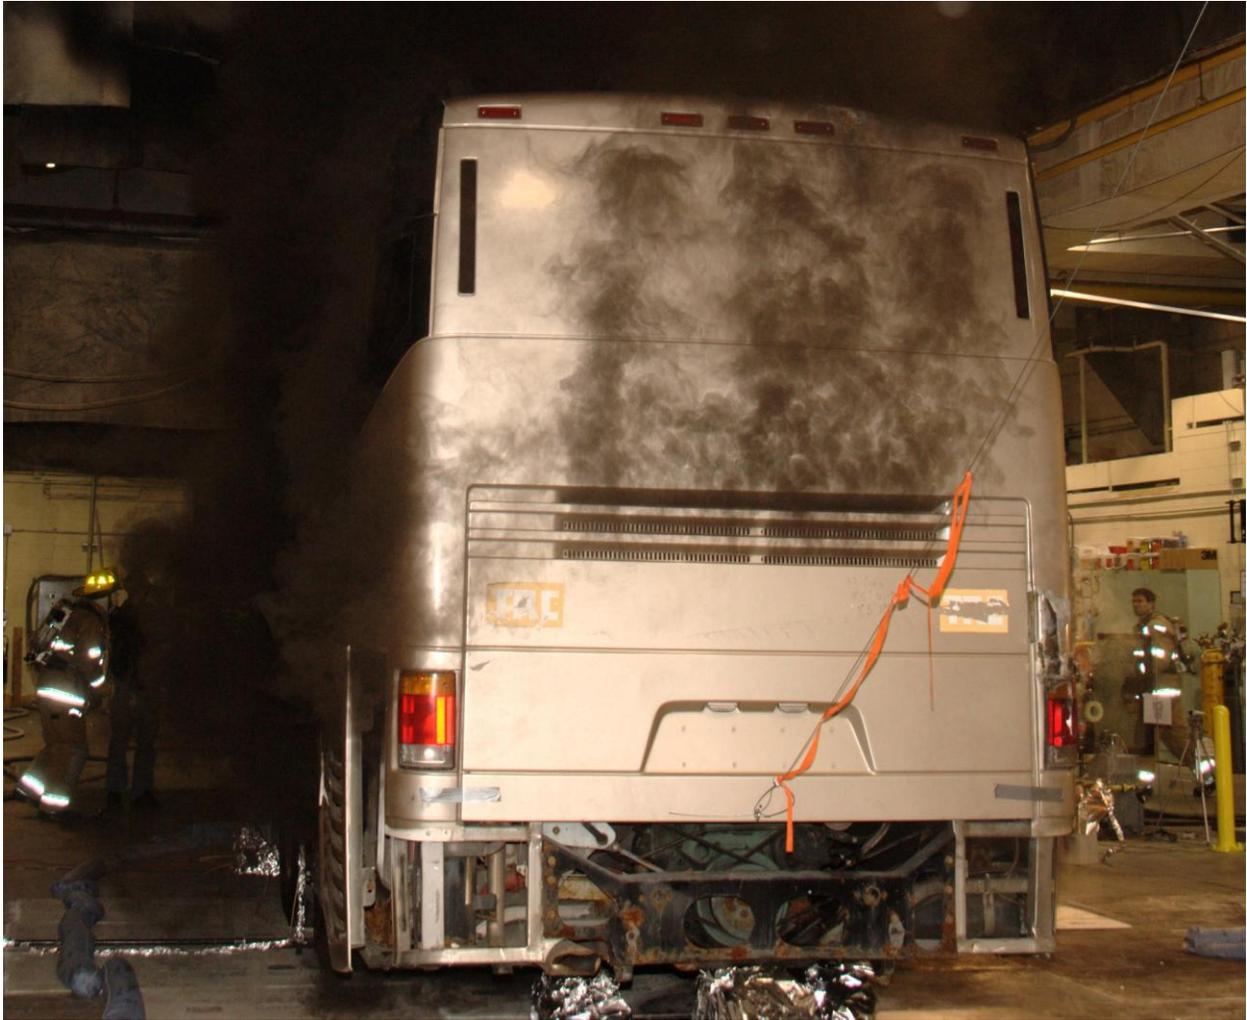
Figure 58 Drive axle wheel heating experiment showing smoke coming from the external air vents.

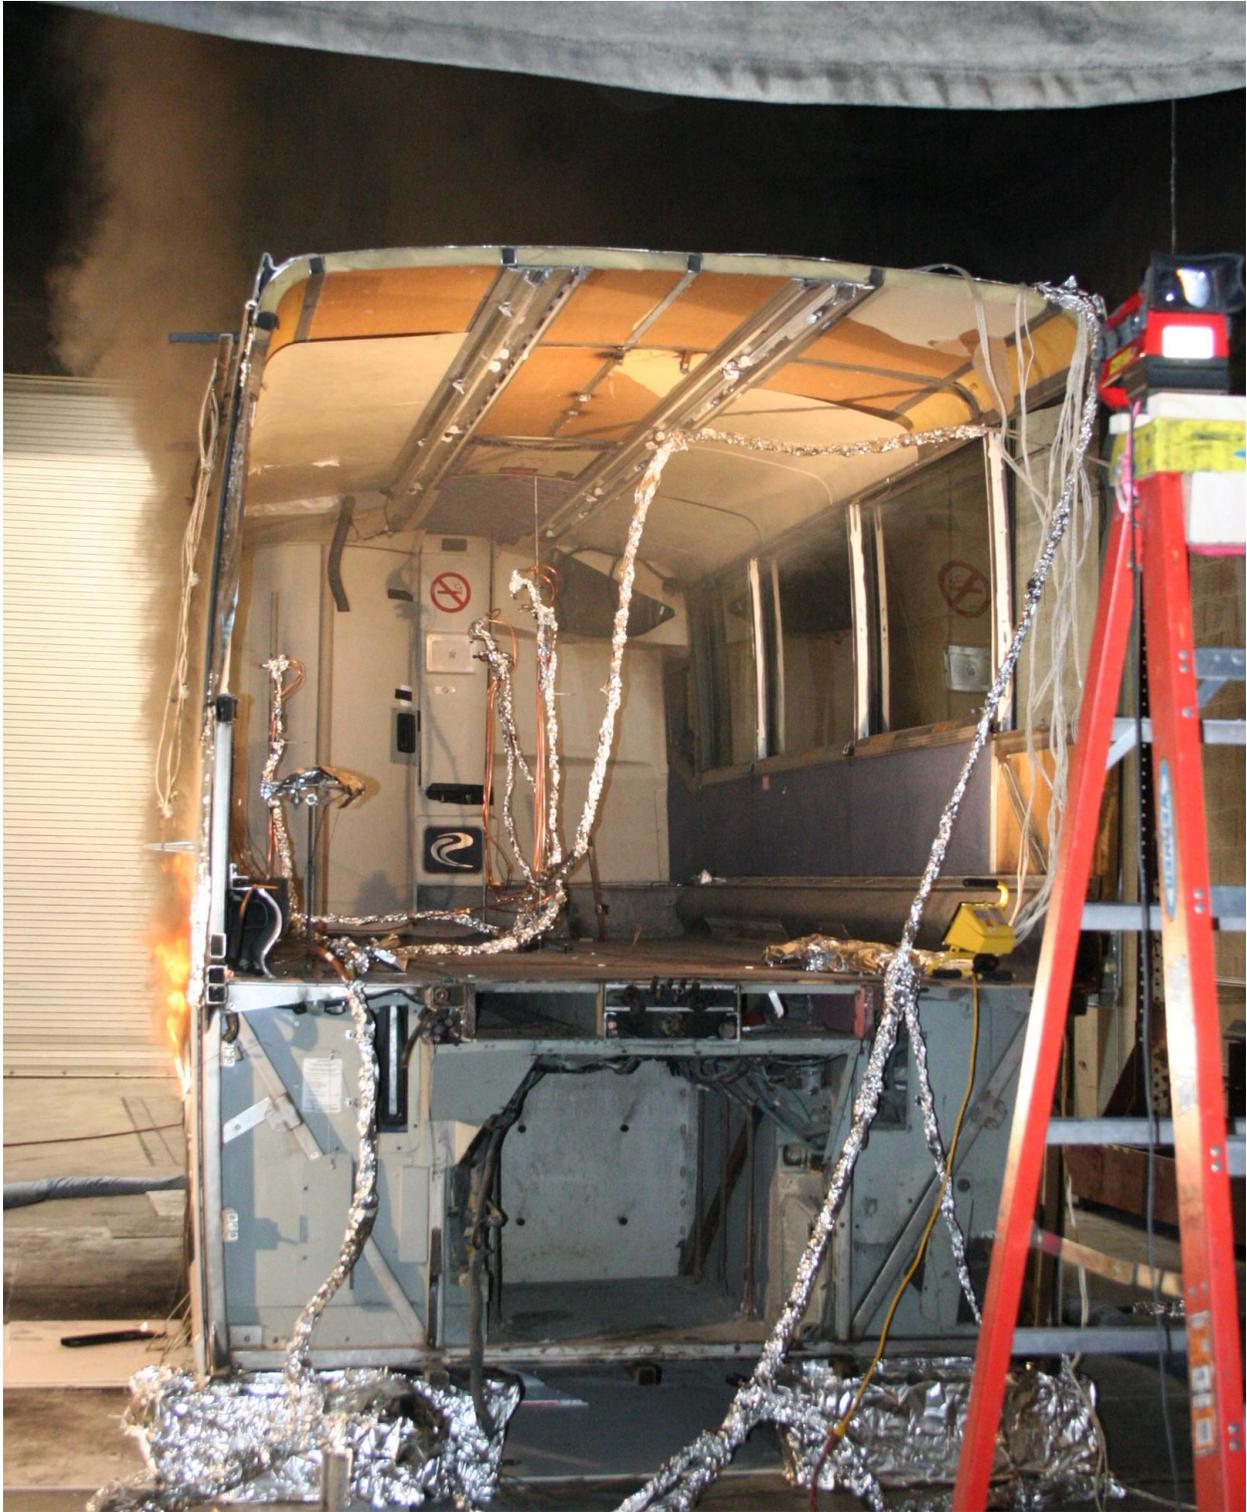
Figure 59 Drive axle wheel heating experiment just over 1 min after burner was removed.

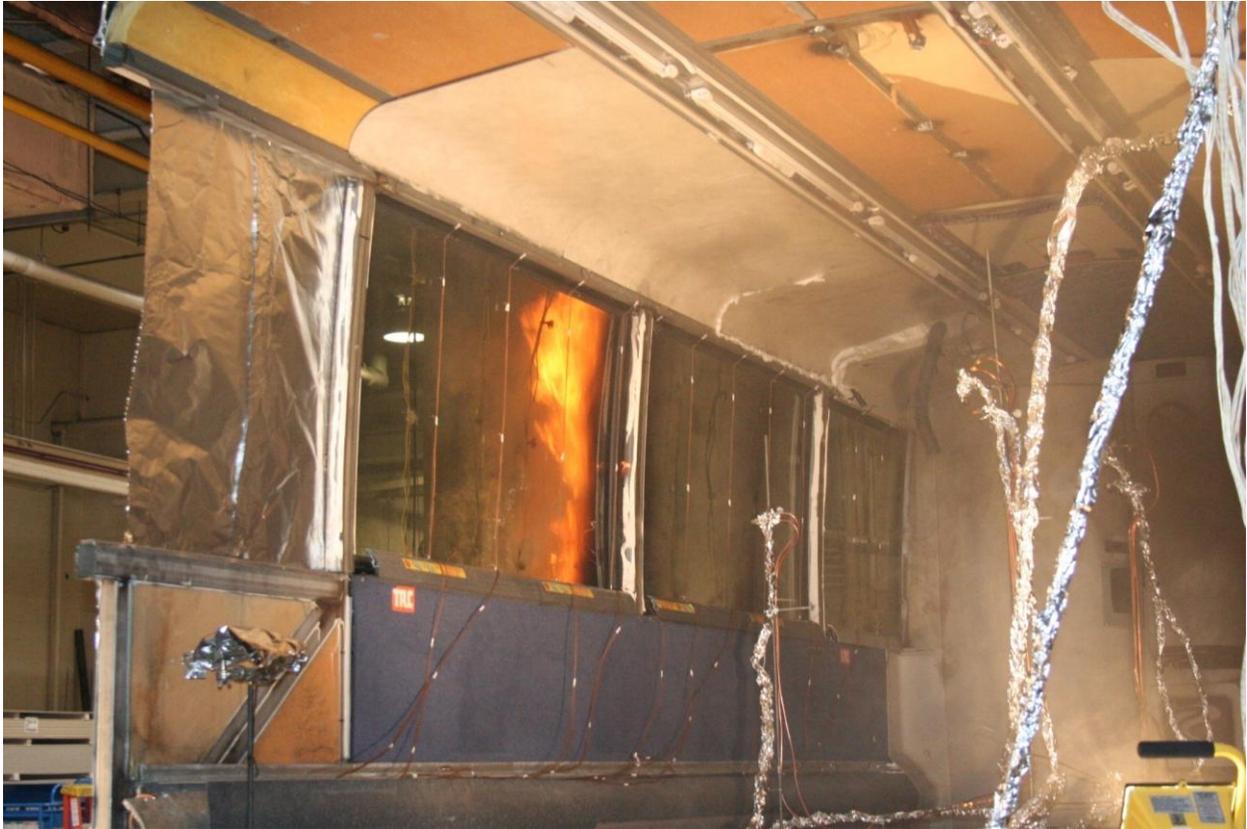
Figure 61 Drive axle wheel heating experiment about 3 min after the burner was removed showing a view of the fire plume from the interior.

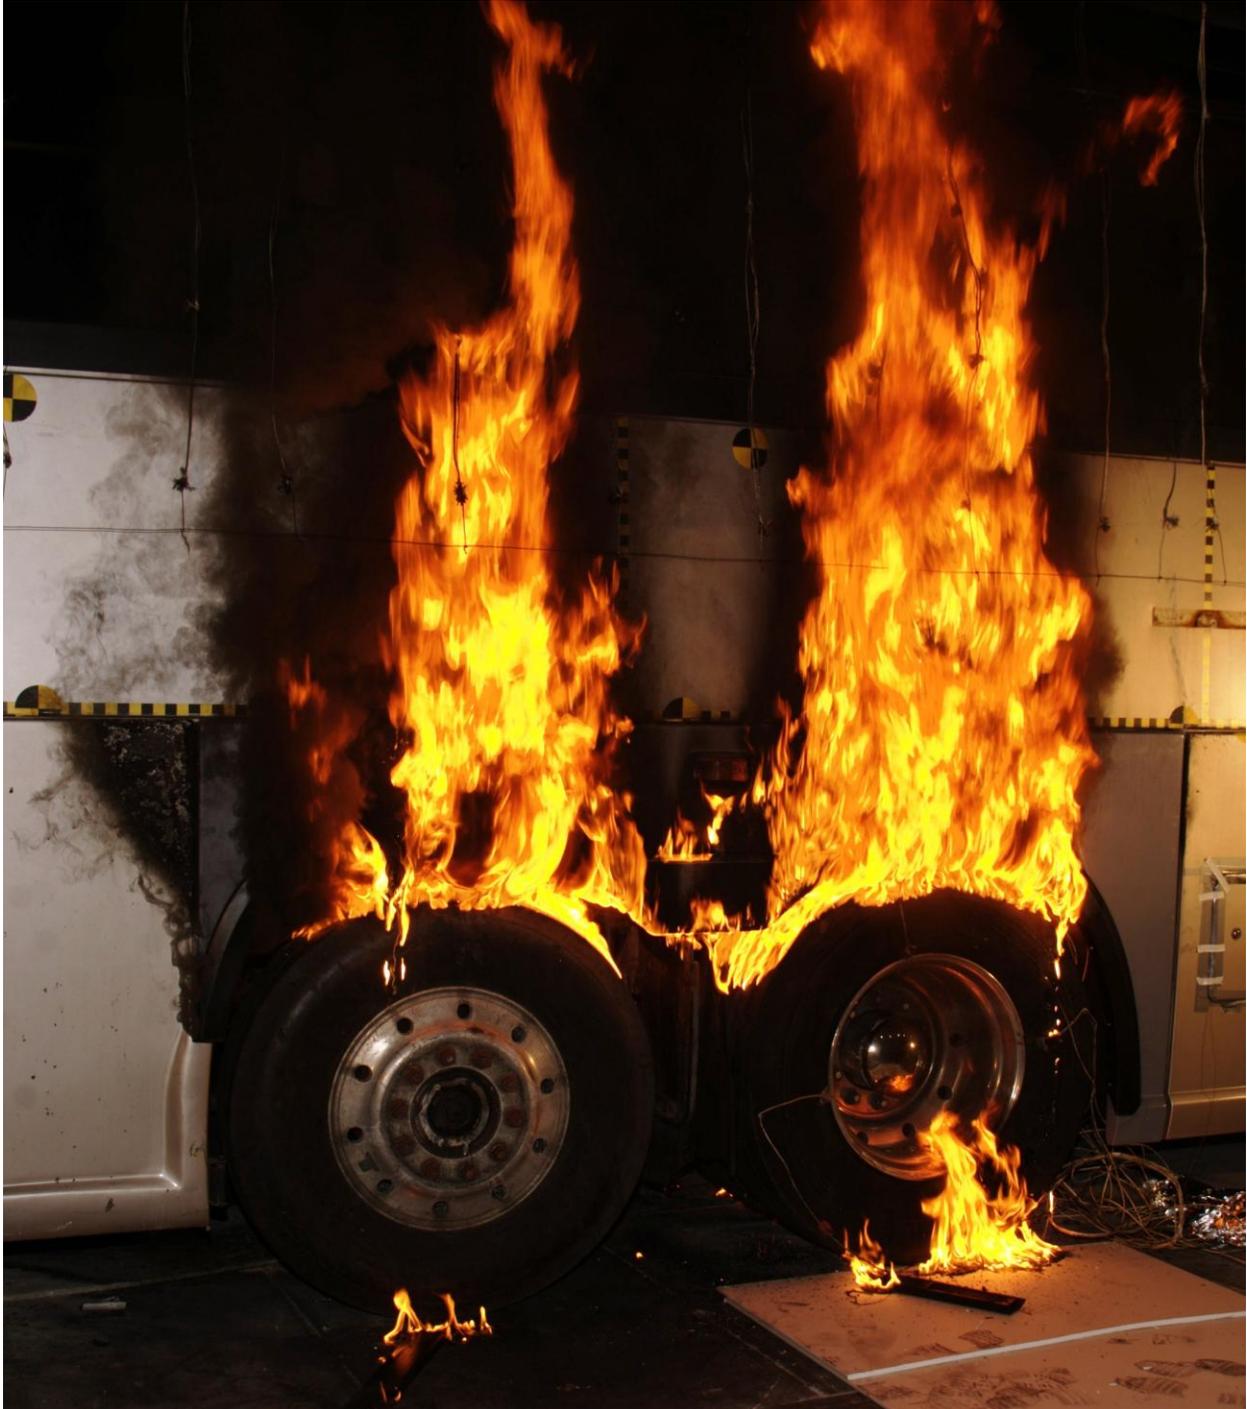
Figure 62 Drive axle wheel heating experiment showing large fire plumes on each tire.

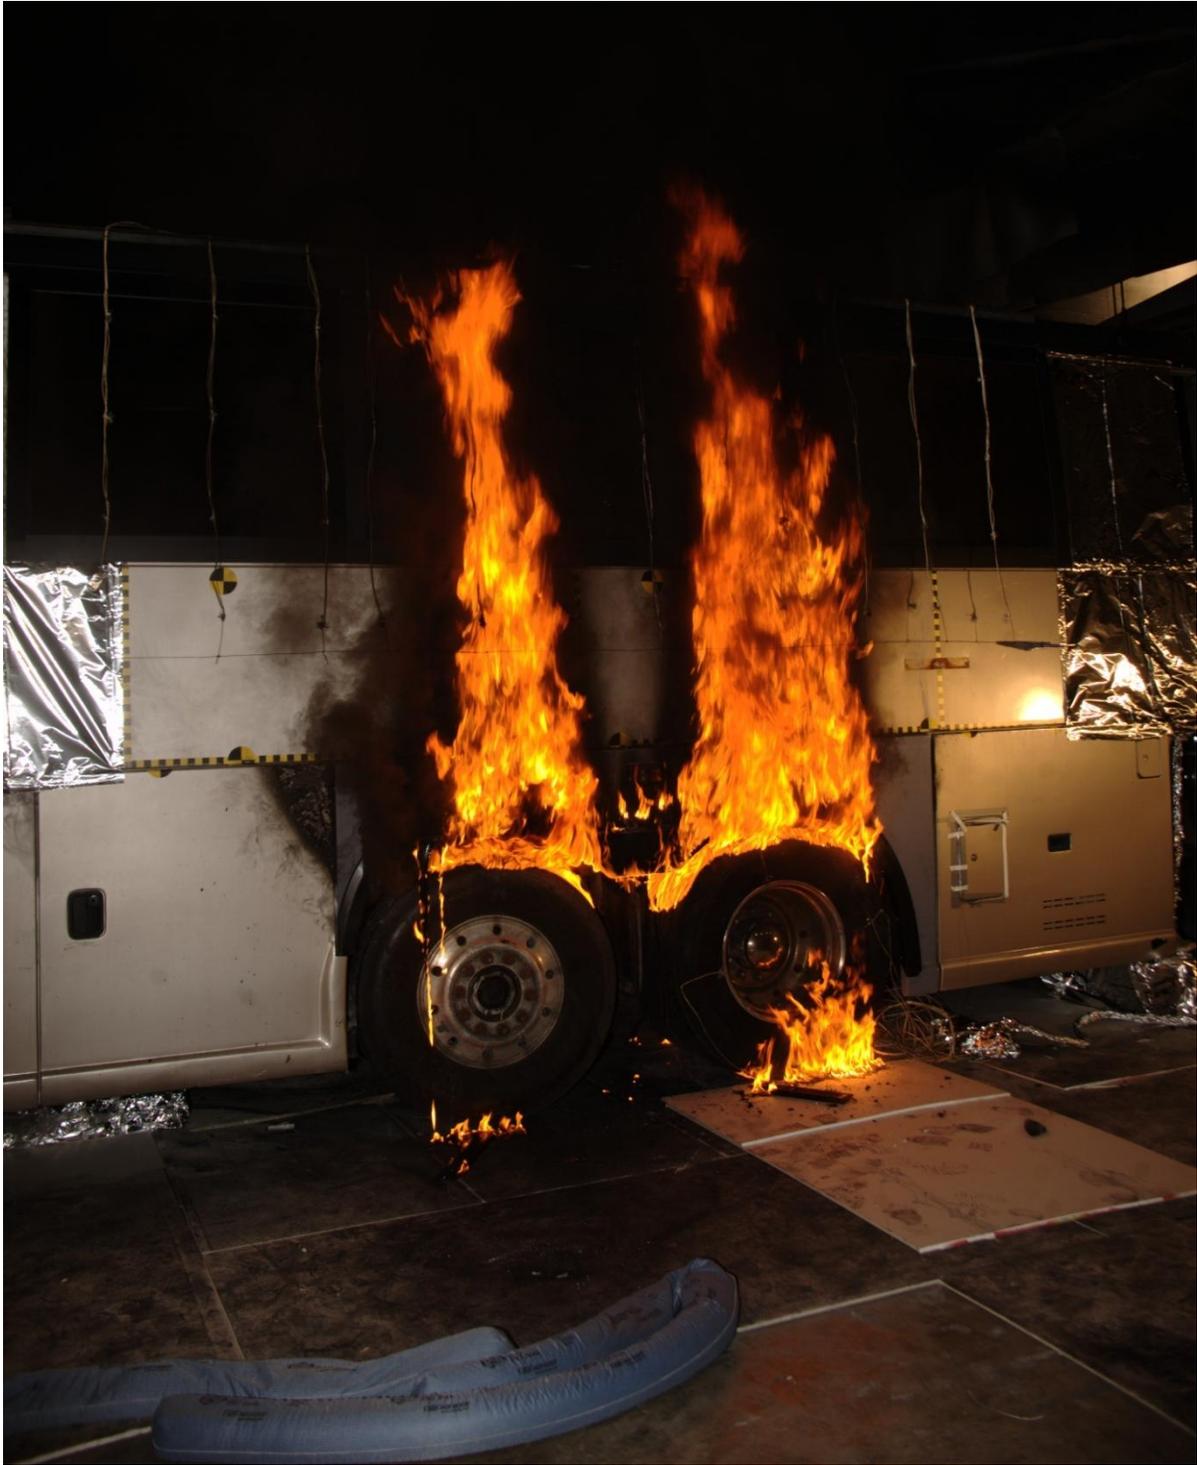
Figure 63 Drive axle wheel heating experiment showing large fire plumes on each tire.

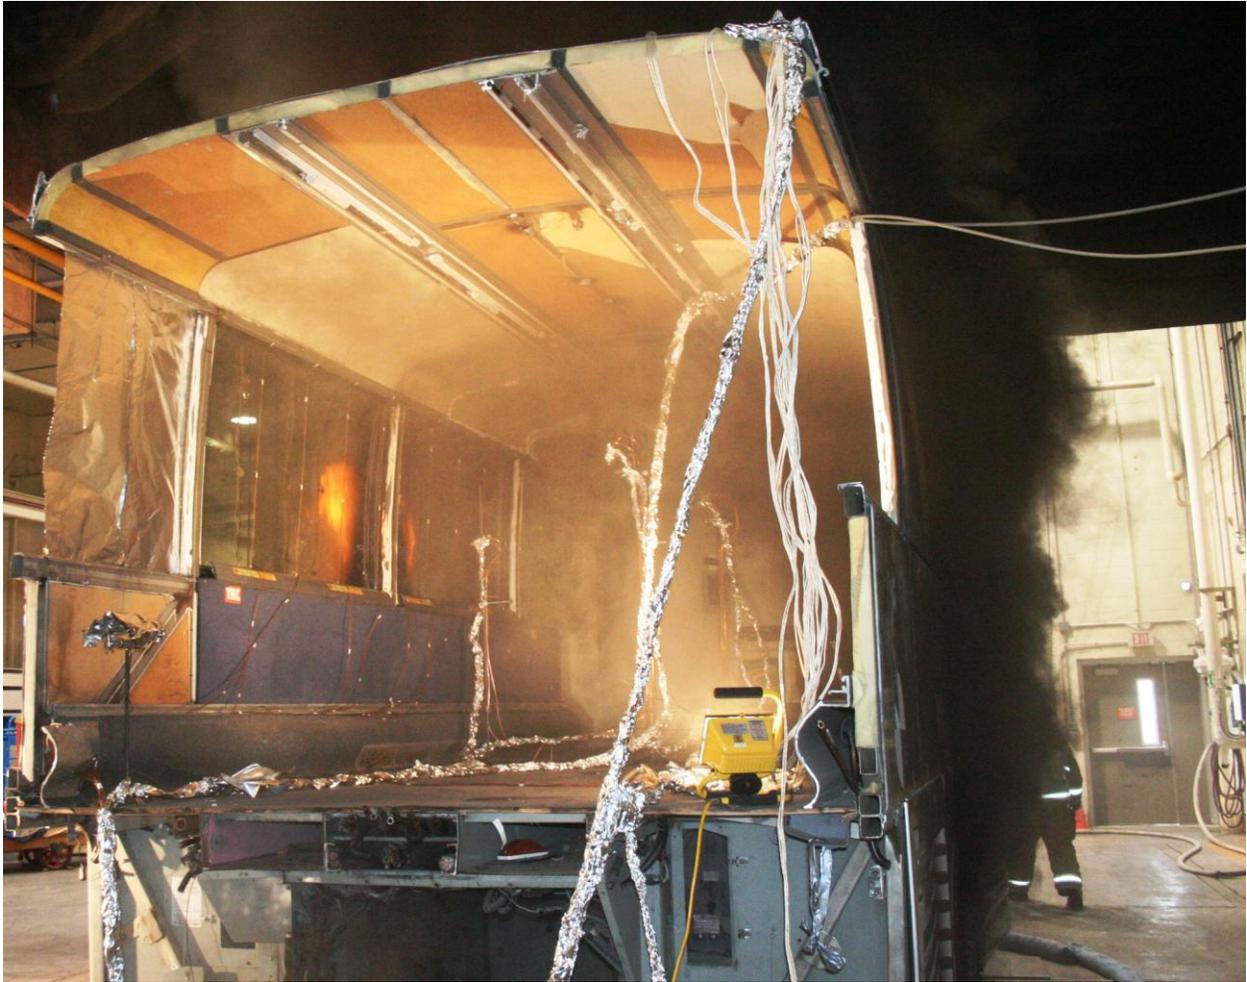
Figure 64 Drive axle wheel heating experiment showing smoke on driver's side 4 min after burner removed.

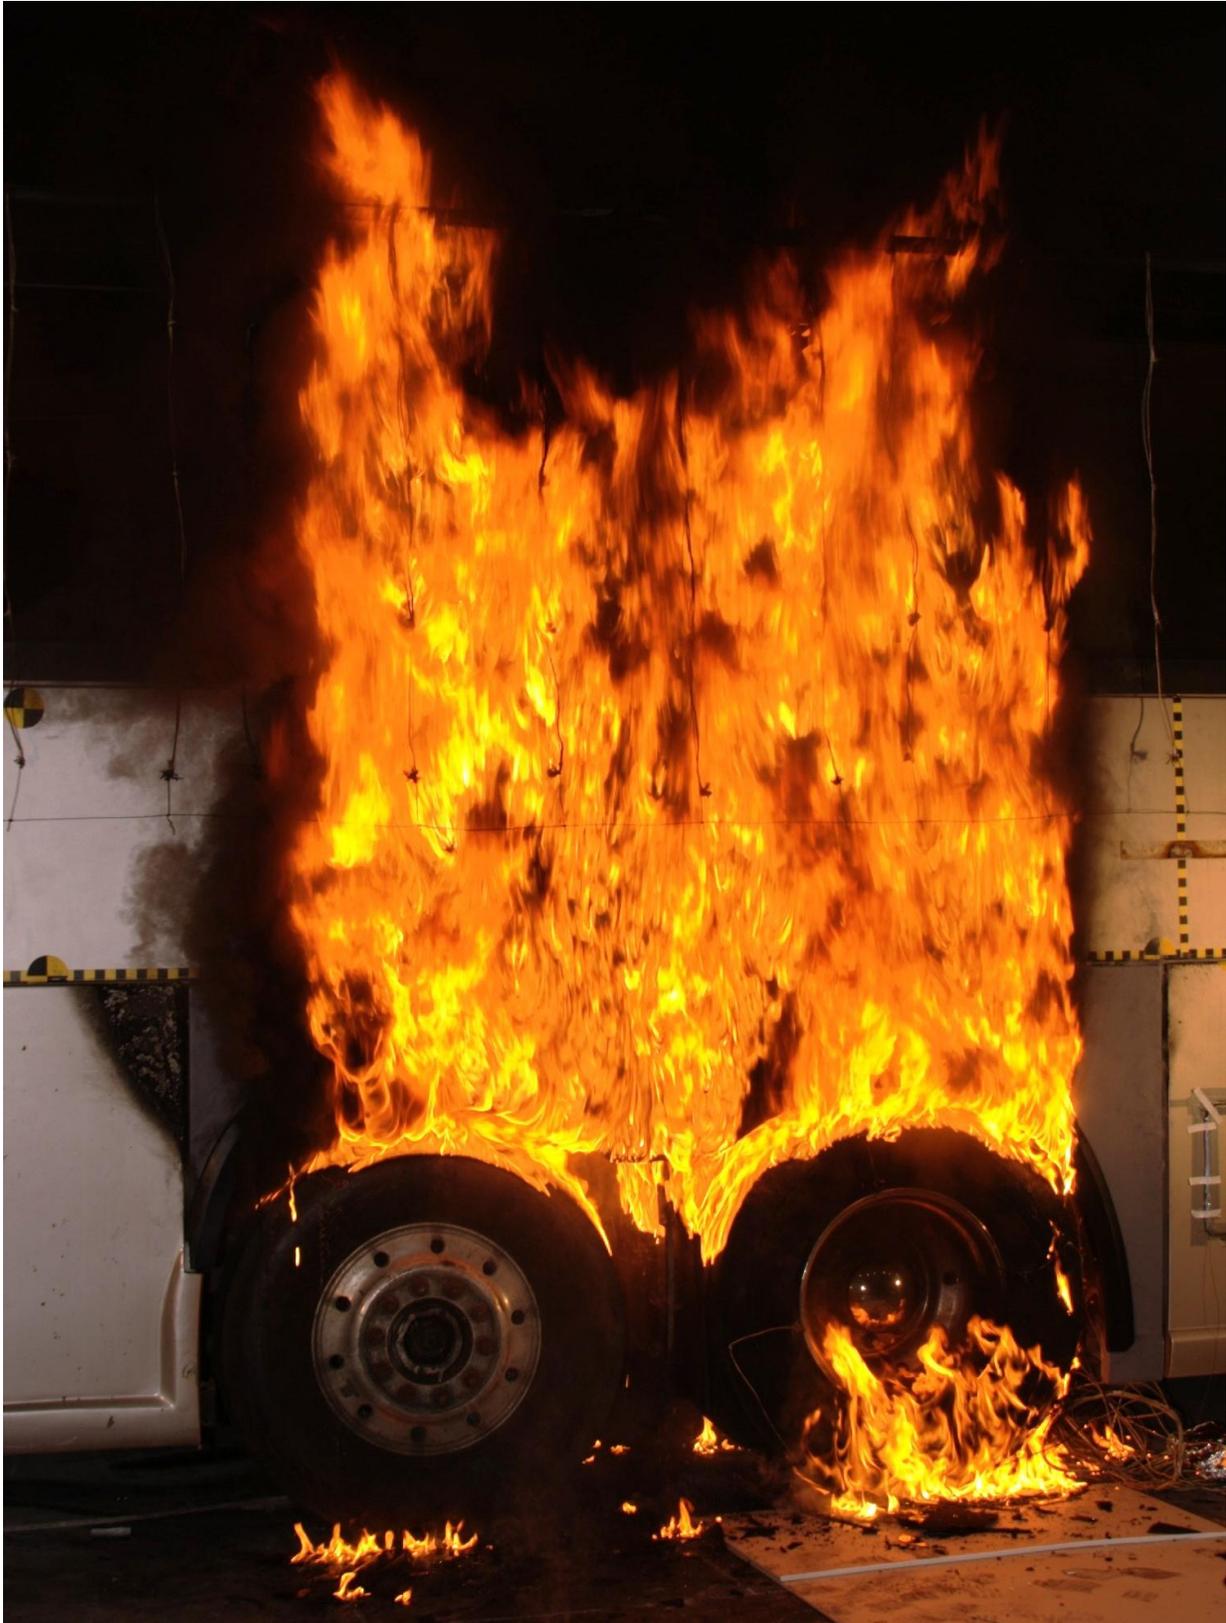
Figure 65 Drive axle wheel heating experiment showing the joined fire plumes within 2 min of fire penetration.

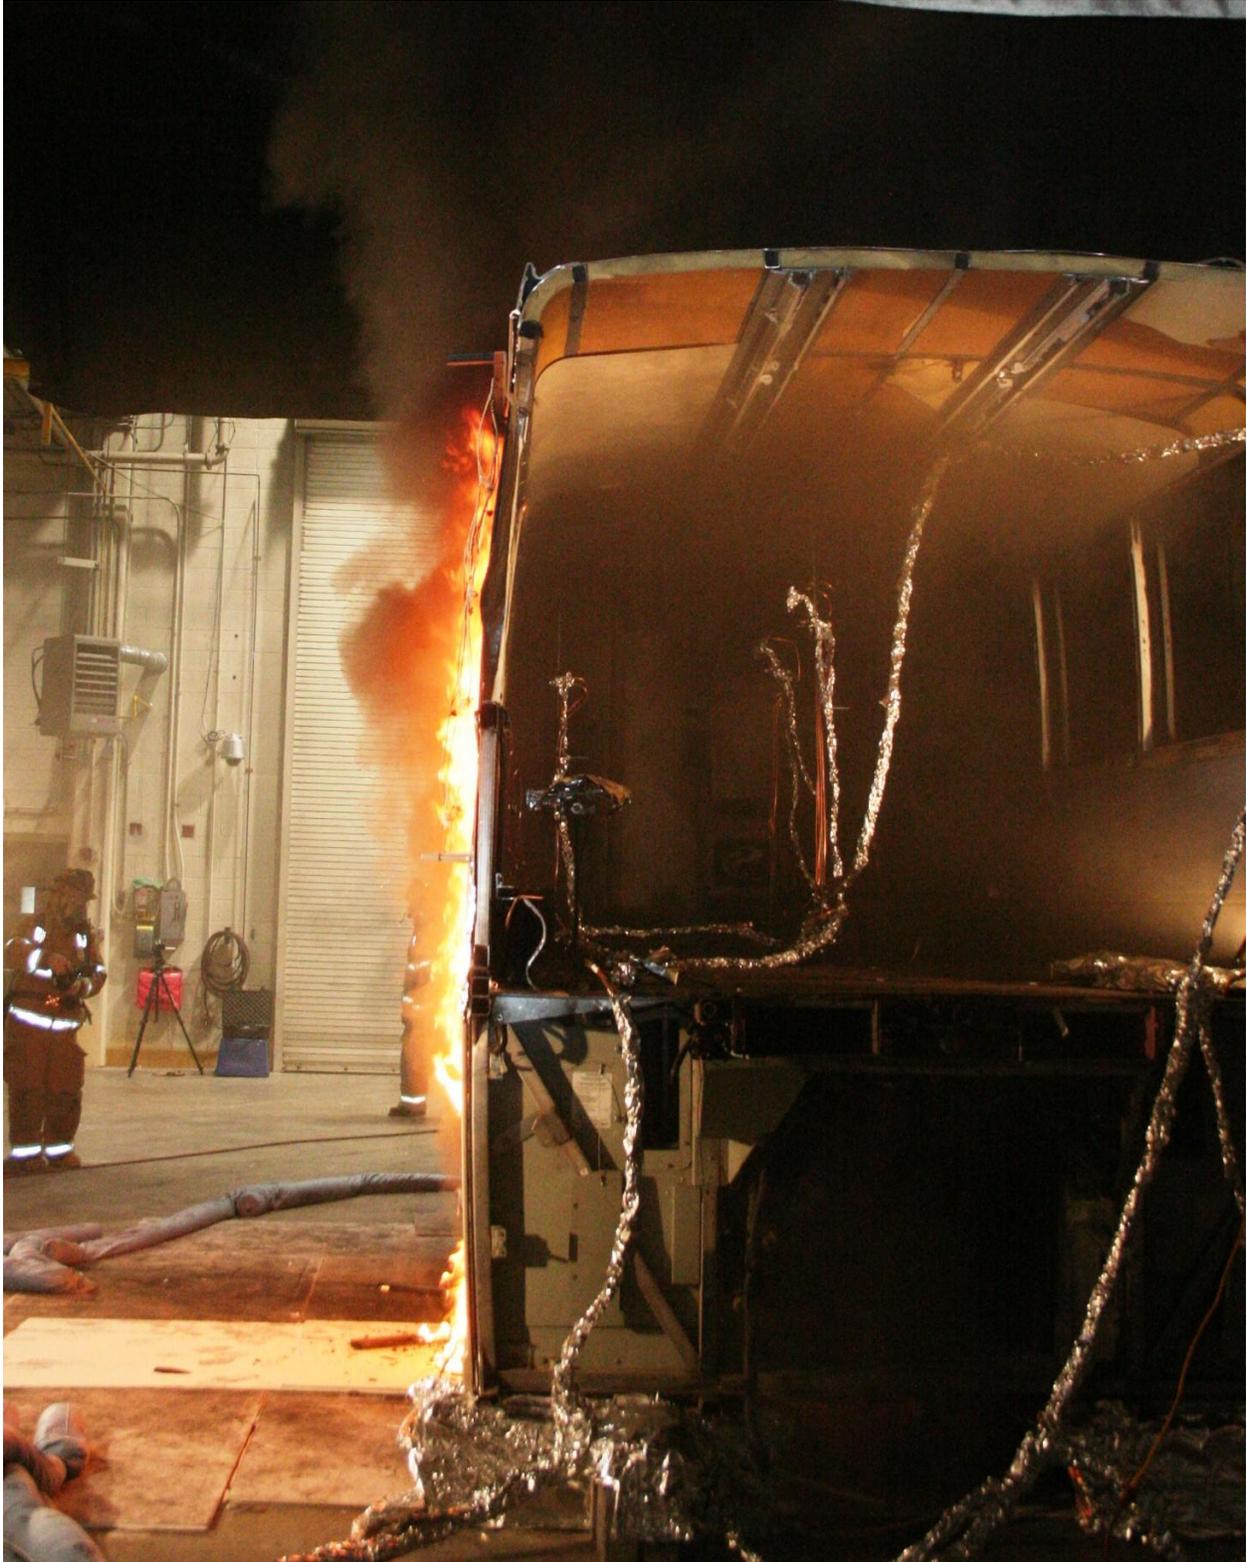
Figure 66 Drive axle wheel heating experiment just under 5 min after burner removal.

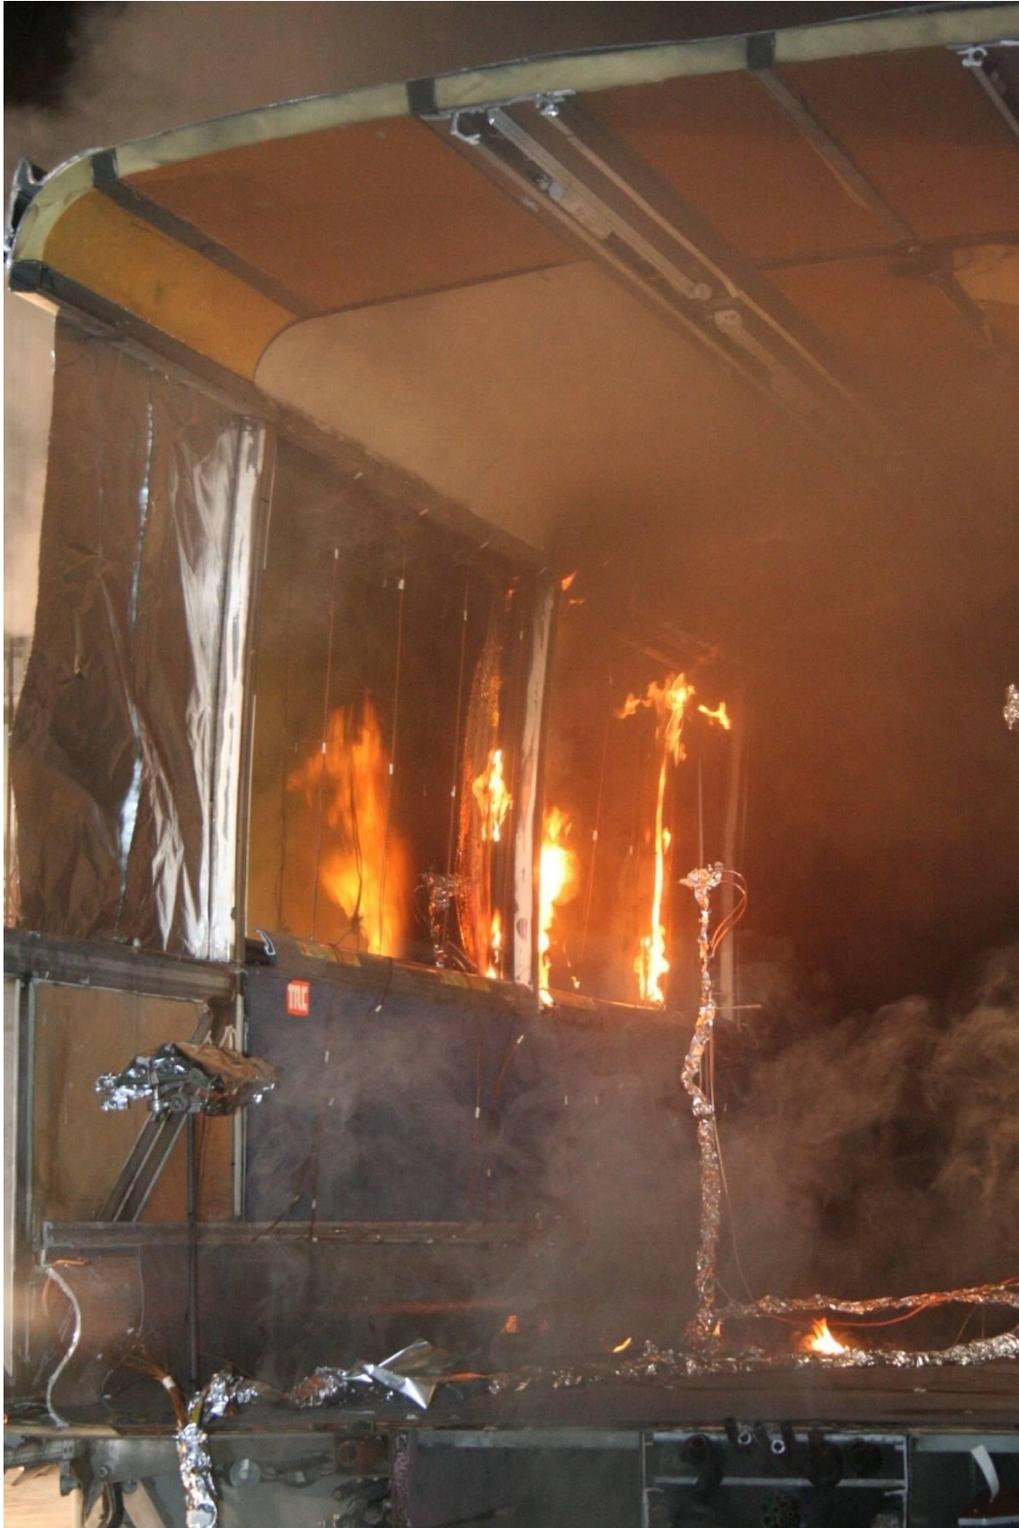
Figure 68 Drive axle wheel heating experiment within a few seconds of fire penetration and at the very beginning of extinguishment.
